Access Compliance Report

Public Rights-of-Way

(Curb Ramps)

| Intersection ID: 10042078 | Main Street: WINSLET_DR | Cross Street: N/A | Location: | N |

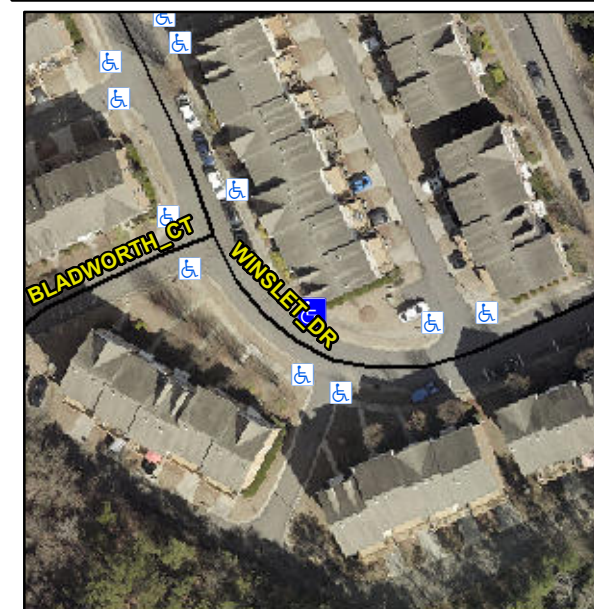
| ADA ID: 9A341F35D887 | Ramp Type: Perp | Initial Pass/Fail: Fail | Overall Compliance: No | Severity Score: 35 |

Not Found, R304.5.1, R304.2.2, R304.5.3

| Compliance | Description | Data | Compliance | Description | Data |
|---|---|---|---|---|---|
| N/A | Ramp Length (in) | 54.0 | No | Ramp Slope (%) | 12.2 |
| No | Ramp Width (in) | 47.0 | No | Ramp XSlope (%) | 2.8 |

Possible Solutions:

Remove & Replace Entire Ramp.
