# Access Compliance Report

## Public Rights-of-Way

### (Curb Ramps)

Intersection ID: 49390	Main Street: DISTRICT_DR	Cross Street: SHORTHORN_ST	Location: NW
ADA ID: 9A38FF85DAD7	Ramp Type: Combination1	Initial Pass/Fail: Fail	Overall Compliance: No
			Severity Score: 46.25

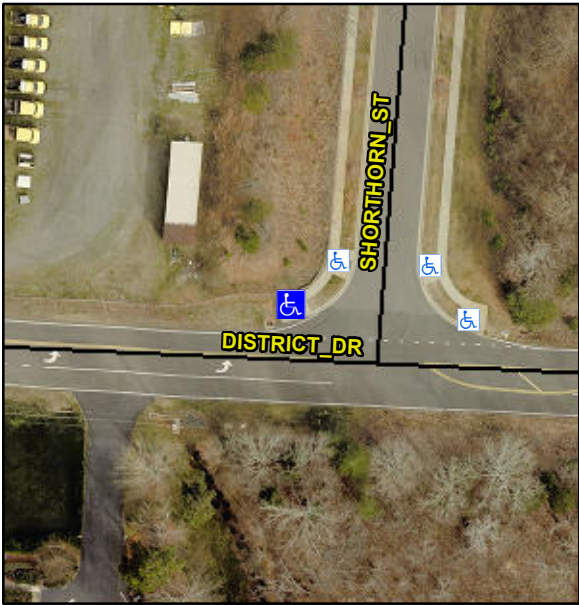
Possible Solutions:			<b>Compliance</b>	<b>Description</b>	<b>Data</b>	<b>Compliance</b>	<b>Description</b>	<b>Data</b>
	<b>Remove &amp; Replace Entire Ramp.</b>			N/A	Ramp Length LT (in)	62.5	N/A	Ramp Length RT (in)	48.0
				Yes	Ramp Width LT (in)	60.0	Yes	Ramp Width RT (in)	60.0
				No	Ramp Slope LT (%)	11.1	No	Ramp Slope RT (%)	10.1
				No	Ramp XSlope LT (%)	2.4	Yes	Ramp XSlope RT (%)	0.5
				N/A	Ramp Length (in)	72.0	Yes	Ramp Slope (%)	4.5
				No	Ramp Width (in)	47.0	No	Ramp XSlope (%)	8.6
	Surveyor Notes:			N/A	Flare Type LT	N/A	N/A	Flare Type RT	N/A
	<b>DWS LIP 1.0"</b>			N/A	Flare Slope LT (%)	N/A	N/A	Flare Slope RT (%)	N/A
				N/A	Flare Traversable LT?	N/A	N/A	Flare Traversable RT?	N/A
PROW/ADA:			N/A	Landing Length (in)	N/A	N/A	DWS Provided?	N/A	
<b>Not Found, R304.5.1, R304.5.3, R304.3.2</b>			N/A	Landing Width (in)	N/A	N/A	DWS Contrast?	N/A
