Access Compliance Report

Public Rights-of-Way

(Curb Ramps)

Intersection ID: 4891	Main Street: GRANARD_LN	Cross Street: PAINTED_PONY_CT	Location: NW
ADA ID: 9A3A50F6D92C	Ramp Type: Perp	Initial Pass/Fail: Fail	Overall Compliance: No
Codes/Mitigation Info/Possible Solution		Field Measurements/Component Compliance	
Severity Score: 13.75

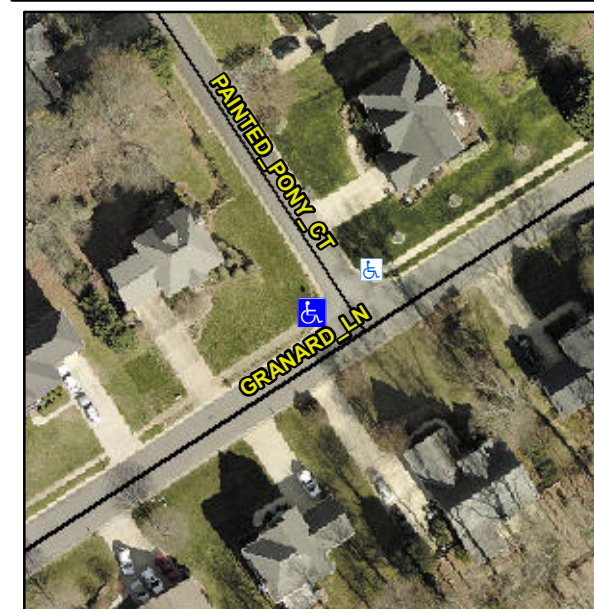
PROW/ADA:

Not Found, R304.2.2, R304.5.3

Compliance	Description	Data	Compliance	Description	Data
N/A	Ramp Length (in)	49.0	No	Ramp Slope (%)	10.2
Yes	Ramp Width (in)	49.0	No	Ramp XSlope (%)	3.4
N/A	Flare Type LT	N/A	N/A	Flare Type RT	N/A
N/A	Flare Slope LT (%)	N/A	N/A	Flare Slope RT (%)	N/A
N/A	Flare Traversable LT?	N/A	N/A	Flare Traversable RT?	N/A
N/A	Landing Length (in)	N/A	N/A	DWS Provided?	N/A
N/A	Landing Width (in)	N/A	N/A	DWS Contrast?	N/A
N/A	Landing Slope (%)	N/A	N/A	DWS Length (in)	N/A
N/A	Landing X Slope (%)	N/A	N/A	DWS Full Width?	N/A
N/A	Landing Curb? (Y/N)	N/A	N/A	DWS Offset (in)	N/A
N/A	Shared Landing?	N/A			
N/A	Gutter Ponding?	N/A	N/A	Gutter Slope (%)	N/A
N/A	Gutter Lip Ht (in)	N/A	N/A	Gutter X Slope (%)	N/A
N/A	Painted X Walk1?	No	N/A	Painted X Walk2?	N/A
	X Walk 1 Direction	To NE		X Walk 2 Direction	N/A
N/A	X Walk 1 Width (in)	N/A	N/A	X Walk 2 Width (in)	N/A
	X Walk 1 Slope (%)	3.5		X Walk 2 Slope (%)	N/A
	X Walk 1 X Slope (%)	3.5		X Walk 2 X Slope (%)	N/A

N/A	Ramp inside XWalk1?	N/A	N/A	Ramp inside XWalk2?	N/A
	Road Slope (%)	N/A	N/A	Clear Space?	N/A
	Road X Slope (%)	N/A	N/A	Clear Space to XWalk (in)	N/A
N/A	Any Obstructions?	N/A	N/A	Storm Grate/Utility Hazard?	N/A
	Obstruction Type			Storm Grate/Utility Type	
		N/A			N/A
		Yes		Surface Condition? (G/P)	Good

Possible Solutions:

Remove & Replace Entire Ramp.
