## Access Compliance Report Public Rights-of-Way (Curb Ramps)

Intersection ID: N/A Main Street: MILLENNIUM\_AV Cross Street: CITY\_PARK\_DR Location: SE

ADA ID: 9A3CA970F1D9 Ramp Type: Perp Initial Pass/Fail: Fail Overall Compliance: No Severity Score: 1.25

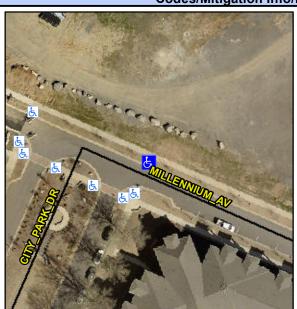
N/
PROW/ADA:
Not Found, R304.5.3

Field Measurements/Component Compliance					
Compliance Description		Data	Comp	liance Description	Data
N/A	Ramp Length (in)	88.0	Yes	Ramp Slope (%)	7.9
Yes	Ramp Width (in)	71.0	No	Ramp XSlope (%)	3.5
N/A	Flare Type LT	N/A	N/A	Flare Type RT	N/A
N/A	Flare Slope LT (%)	N/A	N/A	Flare Slope RT (%)	N/A
N/A	Flare Traversable LT?	N/A	N/A	Flare Traversable RT?	N/A
N/A	Landing Length (in)	N/A	N/A	DWS Provided?	N/A
N/A	Landing Width (in)	N/A	N/A	DWS Contrast?	N/A
N/A	Landing Slope (%)	N/A	N/A	DWS Length (in)	N/A
N/A	Landing X Slope (%)	N/A	N/A	DWS Full Width?	N/A
N/A	Landing Curb? (Y/N)	N/A	N/A	DWS Offset (in)	N/A
N/A	Shared Landing?	N/A			
N/A	Gutter Ponding?	N/A	N/A	Gutter Slope (%)	N/A
N/A	Gutter Lip Ht (in)	N/A	N/A	Gutter X Slope (%)	N/A
N/A	Painted X Walk1?	No	N/A	Painted X Walk2?	N/A
	X Walk 1 Direction	To SW		X Walk 2 Direction	N/A
N/A	X Walk 1 Width (in)	N/A	N/A	X Walk 2 Width (in)	N/A
	X Walk 1 Slope (%)	2.1		X Walk 2 Slope (%)	N/A

X Walk 1 X Slope (%)	0.8		X Walk 2 X Slope (%)	N/A
N/A	Ramp inside XWalk1?	N/A	N/A	Ramp inside XWalk2?	N/A
	Road Slope (%)	N/A	N/A	Clear Space?	N/A
	Road X Slope (%)	N/A	N/A	Clear Space to XWalk (in)	N/A
N/A	Any Obstructions?	N/A	N/A	Storm Grate/Utility Hazard?	N/A
	Obstruction Type			Storm Grate/Utility Type	
		N/A			N/A
			Yes	Surface Condition? (G/P)	Good

Remove & Replace Entire Ramp.
