Access Compliance Report

Public Rights-of-Way (Curb Ramps)

Intersection ID: 15049	Main Street: DILWORTH_RD_WEST	Cross Street: MAGNOLIA_AV	Location: SW
ADA ID: 9A3F18BE577D	Ramp Type: Directional1	Initial Pass/Fail: Fail	Overall Compliance: No
Severity Score: 10			
Codes/Mitigation Info/Possible Solution		Field Measurements/Component Compliance

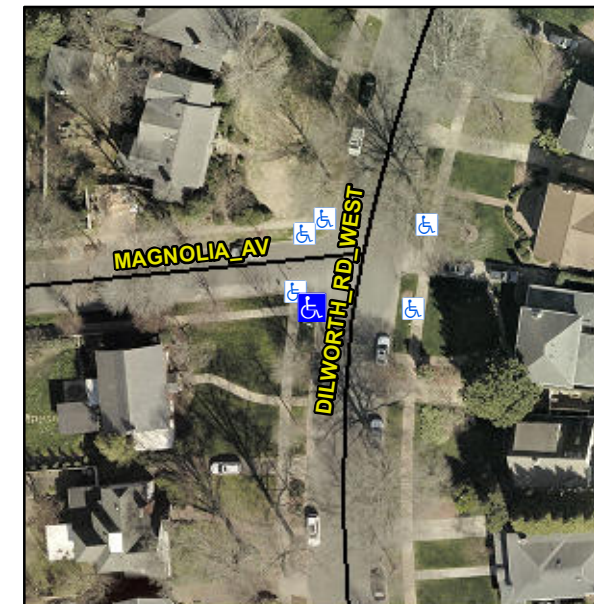
Compliance	Description	Data	Compliance	Description	Data
N/A	Ramp Length (in)	48.0	N/A	Grade Break?	N/A
No	Ramp Width (in)	36.0	N/A	Grade Break Slope (%)	0.0
Yes	Ramp Slope (%)	5.4	N/A	Grade Break XSlope (%)	0.0
No	Ramp XSlope (%)	5.0			
N/A	Flare Type LT	N/A	N/A	Flare Type RT	N/A
N/A	Flare Slope LT (%)	N/A	N/A	Flare Slope RT (%)	0.0
N/A	Flare Traversable LT?	N/A	N/A	Flare Traversable RT?	N/A
N/A	Landing Length (in)	0.0	N/A	DWS Provided?	N/A
N/A	Landing Width (in)	0.0	N/A	DWS Contrast?	N/A
N/A	Landing Slope (%)	0.0	N/A	DWS Length (in)	N/A
N/A	Landing X Slope (%)	0.0	N/A	DWS Full Width?	N/A
N/A	Landing Curb? (Y/N)	N/A	N/A	DWS Offset LT (in)	N/A
N/A	Shared Landing?	N/A	N/A	DWS Offset RT (in)	N/A
N/A	Gutter Ponding?	0.0	N/A	Gutter Slope (%)	N/A
N/A	Gutter Lip Ht (in)	0.0	N/A	Gutter X Slope (%)	N/A
N/A	Painted X Walk1?	No		Road Slope (%)	6.0
	X Walk 1 Direction	To E		Road X Slope (%)	0.6
	X Walk 1 Width (in)	N/A		Clear Space?	N/A

X Walk 1 Slope (%)	6.0	N/A	Clear Space to XWalk (in)	N/A
	X Walk 1 X Slope (%)	0.6	N/A	Storm Grate/Utility Hazard?	N/A
N/A	Ramp inside XWalk1?	N/A		Storm Grate/Utility Type	
N/A	Any Obstructions?	N/A			N/A
	Obstruction Type		Yes	Surface Condition? (G/P)	Good
			N/A	Curb Slope (%)	2.9

Possible Solutions:

Remove & Replace Entire Ramp.

PROW/ADA:

R304.5.1, R304.5.3
