# Access Compliance Report

## Public Rights-of-Way

### (Curb Ramps)

| Intersection ID: 12874 | Main Street: JACKSON_AV | Cross Street: PIEDMONT_ST | Location: SW |

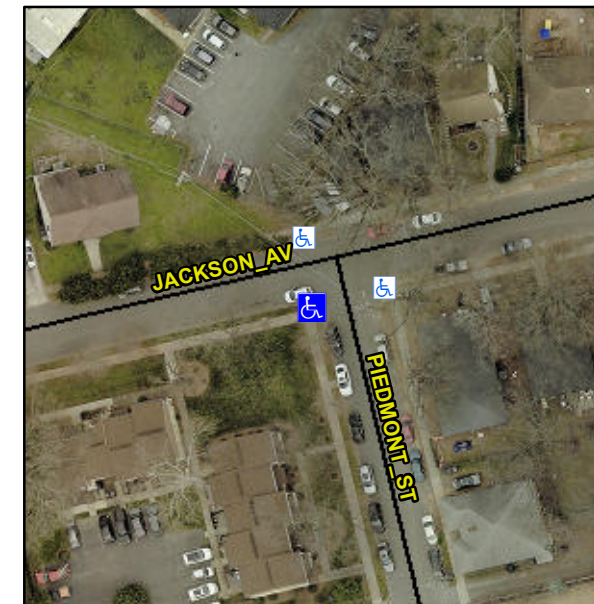
| ADA ID: 9A4223A6ACD6 | Ramp Type: BlendTrans2 | Initial Pass/Fail: Pass | Overall Compliance: No |
| Severity Score: 7.75 | | | |

| Compliance | Description | Data | Compliance | Description | Data |
|---|---|---|---|---|---|
| Yes | Ramp Width (in) | 48.0 | No | BlendTrans XSlope (%) | 3.6 |
| No | Gutter Ponding? | Yes | Yes | Gutter Slope (%) | 2.1 |
| No | Gutter Lip Ht (in) | 0.5 | Yes | Gutter X Slope (%) | 1.6 |

**Remove & Replace Curb Ramp With Two New Directional Ramps or Equivalent. Grind Gutter Lip.**

**R304.5.3, R302.7, R302.7.2**
