Access Compliance Report

Public Rights-of-Way

(Curb Ramps)

Intersection ID: 15707	Main Street: DORCHESTER_PL	Cross Street: POINDEXTER_DR	Location:	S
ADA ID: 9A431BA658AB	Ramp Type: ParaDiag	Initial Pass/Fail: Fail	Overall Compliance: No	Severity Score: 30
Codes/Mitigation Info/Possible Solution		Field Measurements/Component Compliance

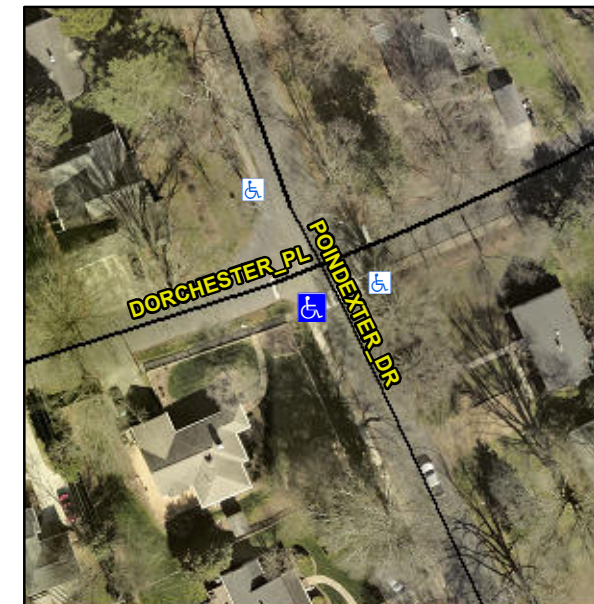
NO CURB

PROW/ADA:

R304.5.1, R304.3.2

Compliance	Description	Data	Compliance	Description	Data
N/A	Ramp Length LT (in)	64.0	N/A	Ramp Length RT (in)	N/A
No	Ramp Width LT (in)	35.0	N/A	Ramp Width RT (in)	N/A
No	Ramp Slope LT (%)	8.5	N/A	Ramp Slope RT (%)	N/A
Yes	Ramp XSlope LT (%)	1.5	N/A	Ramp XSlope RT (%)	N/A
N/A	Landing Length (in)	N/A	N/A	DWS Provided?	N/A
N/A	Landing Width (in)	N/A	N/A	DWS Contrast?	N/A
N/A	Landing Slope (%)	N/A	N/A	DWS Length (in)	N/A
N/A	Landing X Slope (%)	N/A	N/A	DWS Full Width?	N/A
N/A	Landing Curb? (Y/N)	N/A	N/A	DWS Offset (in)	N/A
N/A	Shared Landing?	N/A			
N/A	Gutter Ponding?	N/A	N/A	Gutter Slope (%)	N/A
N/A	Gutter Lip Ht (in)	N/A	N/A	Gutter X Slope (%)	N/A
N/A	Painted X Walk1?	Yes	N/A	Painted X Walk2?	No
	X Walk 1 Direction	To NE		X Walk 2 Direction	To NW
N/A	X Walk 1 Width (in)	84.0	N/A	X Walk 2 Width (in)	N/A
	X Walk 1 Slope (%)	1.9		X Walk 2 Slope (%)	0.1
	X Walk 1 X Slope (%)	1.0		X Walk 2 X Slope (%)	2.0
N/A	Ramp inside XWalk1?	Yes	N/A	Ramp inside XWalk2?	N/A

Road Slope (%)	2.9	N/A	Clear Space?	N/A
	Road X Slope (%)	3.4	N/A	Clear Space to XWalk (in)	N/A
N/A	Any Obstructions?	N/A	N/A	Storm Grate/Utility Hazard?	N/A
	Obstruction Type			Storm Grate/Utility Type	
		N/A			N/A
			Yes	Surface Condition? (G/P)	Good
			N/A	Curb Slope (%)	N/A

Possible Solutions:

Remove & Replace Curb Ramp With Two New Directional Ramps or Equivalent.
