Intersection ID: 47279	Main Street: SAVANNAH_HILLS_DR	Cross Street: CARRINGTON_FOREST_LN	Location:	NW
ADA ID: 9A433A8E31D8	Ramp Type: PerpDiag	Initial Pass/Fail: Fail	Overall Compliance: No	Severity Score: 8.75

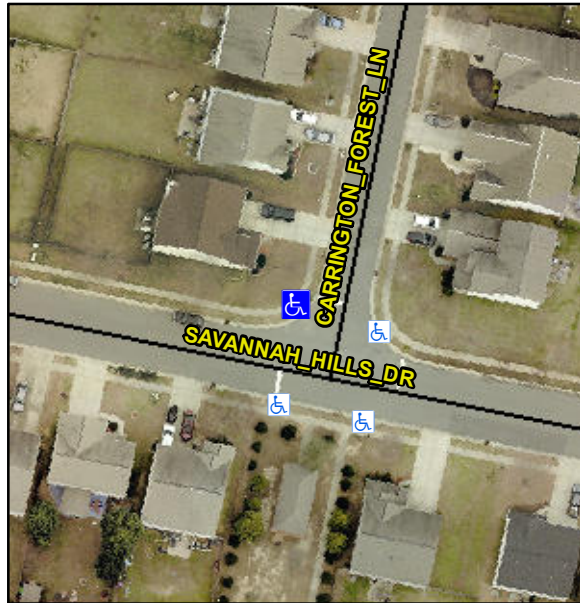
Not Found, R304.5.1

Compliance	Description	Data	Compliance	Description	Data
N/A	Ramp Length (in)	48.0	Yes	Ramp Slope (%)	5.2
No	Ramp Width (in)	46.0	Yes	Ramp XSlope (%)	0.9
N/A	Flare Type LT	N/A	N/A	Flare Type RT	N/A
N/A	Flare Slope LT (%)	N/A	N/A	Flare Slope RT (%)	N/A
N/A	Flare Traversable LT?	N/A	N/A	Flare Traversable RT?	N/A
N/A	Landing Length (in)	N/A	N/A	DWS Provided?	N/A
N/A	Landing Width (in)	N/A	N/A	DWS Contrast?	N/A
N/A	Landing Slope (%)	N/A	N/A	DWS Length (in)	N/A
N/A	Landing X Slope (%)	N/A	N/A	DWS Full Width?	N/A
N/A	Landing Curb? (Y/N)	N/A	N/A	DWS Offset (in)	N/A
N/A	Shared Landing?	N/A			
N/A	Gutter Ponding?	N/A	N/A	Gutter Slope (%)	N/A
N/A	Gutter Lip Ht (in)	N/A	N/A	Gutter X Slope (%)	N/A
N/A	Painted X Walk1?	No	N/A	Painted X Walk2?	No
	X Walk 1 Direction	To S		X Walk 2 Direction	To E
N/A	X Walk 1 Width (in)	N/A	N/A	X Walk 2 Width (in)	N/A
	X Walk 1 Slope (%)	0.4		X Walk 2 Slope (%)	1.7
	X Walk 1 X Slope (%)	2.0		X Walk 2 X Slope (%)	0.1

N/A	Ramp inside XWalk1?	N/A	N/A	Ramp inside XWalk2?	N/A
	Road Slope (%)	0.3	N/A	Clear Space?	N/A
	Road X Slope (%)	1.0	N/A	Clear Space to XWalk (in)	N/A
N/A	Any Obstructions?	N/A	N/A	Storm Grate/Utility Hazard?	N/A
	Obstruction Type			Storm Grate/Utility Type	
		N/A			N/A
			Yes	Surface Condition? (G/P)	Good

Remove & Replace Curb Ramp With Two New Directional Ramps or Equivalent.

Total Cost: \$ 3200.00

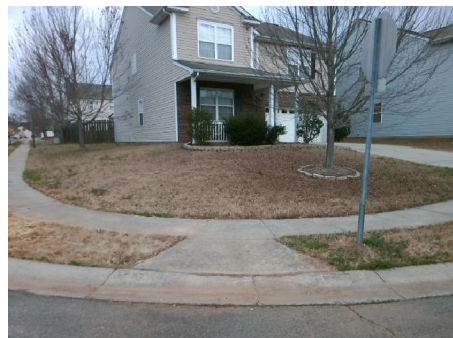
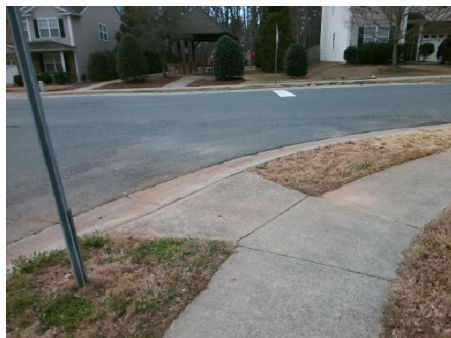
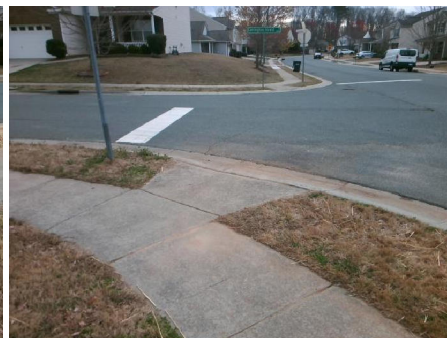
Street 1 Name	SAVANNAH HILLS DR
Stop Condition-Street 2	None
Street 2 Name	CARRINGTON FOREST LN
Stop Condition-Street 1	StopSign
