# Access Compliance Report

## Public Rights-of-Way

### (Curb Ramps)

Intersection ID: N/A	Main Street: YORKMONT_RD	Cross Street: COLLUSEUM CENTRE DR	Location: SW
ADA ID: 9A4394AED682	Ramp Type: Combination1Diag	Initial Pass/Fail: Fail	Overall Compliance: No
		Severity Score: 0

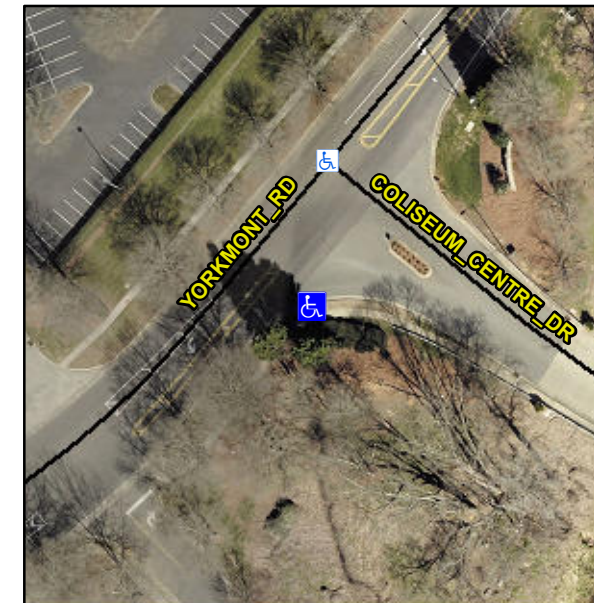
**LT RP < 5%**

**R304.5.3, R304.3.2**

Compliance	Description	Data	Compliance	Description	Data
N/A	Ramp Length LT (in)	63.0	N/A	Ramp Length RT (in)	63.5
Yes	Ramp Width LT (in)	66.5	Yes	Ramp Width RT (in)	62.0
Yes	Ramp Slope LT (%)	2.8	No	Ramp Slope RT (%)	12.5
No	Ramp XSlope LT (%)	2.3	No	Ramp XSlope RT (%)	4.6
N/A	Ramp Length (in)	48.0	Yes	Ramp Slope (%)	5.7
Yes	Ramp Width (in)	48.0	No	Ramp XSlope (%)	6.1
N/A	Flare Type LT	N/A	N/A	Flare Type RT	N/A
N/A	Flare Slope LT (%)	N/A	N/A	Flare Slope RT (%)	N/A
N/A	Flare Traversable LT?	N/A	N/A	Flare Traversable RT?	N/A
N/A	Landing Length (in)	N/A	N/A	DWS Provided?	N/A
N/A	Landing Width (in)	N/A	N/A	DWS Contrast?	N/A
N/A	Landing Slope (%)	N/A	N/A	DWS Length (in)	N/A
N/A	Landing X Slope (%)	N/A	N/A	DWS Full Width?	N/A
N/A	Landing Curb? (Y/N)	N/A	N/A	DWS Offset (in)	N/A
N/A	Shared Landing?	N/A			
N/A	Gutter Ponding?	N/A	N/A	Gutter Slope (%)	N/A
N/A	Gutter Lip Ht (in)	N/A	N/A	Gutter X Slope (%)	N/A
N/A	Painted X Walk1?	No	N/A	Painted X Walk2?	No

X Walk 1 Direction	To NE		X Walk 2 Direction	To NW
	X Walk 1 Width (in)	N/A		X Walk 2 Width (in)	N/A
	X Walk 1 Slope (%)	4.0		X Walk 2 Slope (%)	3.5
	X Walk 1 X Slope (%)	5.5		X Walk 2 X Slope (%)	4.9
N/A	Ramp inside XWalk1?	N/A	N/A	Ramp inside XWalk2?	N/A
	Road Slope (%)	6.7		Clear Space?	N/A
	Road X Slope (%)	1.4	N/A	Clear Space to XWalk (in)	N/A
			N/A	Any Obstruction?	N/A
				Obstruction Type	N/A
			N/A	Storm Grate/Utility Hazard?	N/A
				Storm Grate/Utility Type	N/A
			Yes	Surface Condition? (G/P)	Good
				Curb Slope (%)	2.1

**Remove & Replace Curb Ramp With Two New Directional Ramps or Equivalent.**
