Access Compliance Report Public Rights-of-Way (Curb Ramps)

Intersection ID: 23178 Main Str	Main Street: OBERWOOD_DR		et:	PROVIDENCE_RD	Location:	SE			
ADA ID: 9A46DAA6BD86 Ramp T	Ramp Type: PerpDiag		s/Fai	il: Fail Overall C	o Severity Score:	22.5			
Codes/Mitigation Info/Possible Solution			Field Measurements/Component Compliance						
La	Possible Solutions:	Co	Compliance Description			Data Compliance Description			
	Remove & Replace Curb Ramp W	/ith N//	Α	Ramp Length (in)	71.0	No	Ramp Slope (%)	11.6	
	Two New Directional Ramps or	No		Ramp Width (in)	41.0	No	Ramp XSlope (%)	4.3	
	Equivalent.	N//	Α	Flare Type LT	N/A	N/A	Flare Type RT	N/A	
		N//	Α	Flare Slope LT (%)	N/A	N/A	Flare Slope RT (%)	N/A	
		N//	Α	Flare Traversable LT?	N/A	N/A	Flare Traversable RT?	N/A	
	ā.	N//	Α	Landing Length (in)	N/A	N/A	DWS Provided?	N/A	
	Surveyor Notes:	N//	Α	Landing Width (in)	N/A	N/A	DWS Contrast?	N/A	
	N/A	N//	Α	Landing Slope (%)	N/A	N/A	DWS Length (in)	N/A	
		N//	Α	Landing X Slope (%)	N/A	N/A	DWS Full Width?	N/A

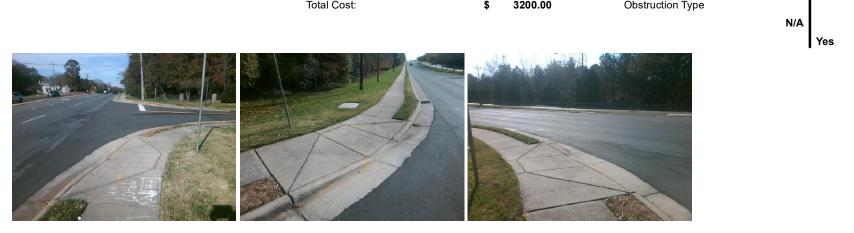
N/.	Α	Landing Curb? (Y/N)	N/A	N/A	DWS Offset (in)	N/A	
		N/.	Α	Shared Landing?	N/A				
	PROW/ADA:	N//	Α	Gutter Ponding?	N/A	N/A	Gutter Slope (%)	N/A	
	Not Found, R304.5.1, R304.2.2,	N//	Α	Gutter Lip Ht (in)	N/A	N/A	Gutter X Slope (%)	N/A	
	R304.5.3	N/	А	Painted X Walk1?	No	N/A	Painted X Walk2?	No	
				X Walk 1 Direction	To N		X Walk 2 Direction	To W	
		N//	А	X Walk 1 Width (in)	N/A	N/A	X Walk 2 Width (in)	N/A	
Street 1 Name OBERWOOD DR				X Walk 1 Slope (%)	2.0		X Walk 2 Slope (%)	4.1	
Stop Condition-Street 2 StopSign				X Walk 1 X Slope (%)	3.2		X Walk 2 X Slope (%)	2.3	
Street 2 Name PROVIDENCE RD		N//	Α	Ramp inside XWalk1?	N/A	N/A	Ramp inside XWalk2?	N/A	
Stop Condition-Street 1 None				Road Slope (%)	1.8	N/A	Clear Space?	N/A	
				Road X Slope (%)	5.8	N/A	Clear Space to XWalk (in)	N/A	
		N/	A	Any Obstructions?	N/A	N/A	Storm Grate/Utility Hazard?	N/A	
	Total Cost: \$ 32	200.00		Obstruction Type			Storm Grate/Utility Type
