## **Access Compliance Report Public Rights-of-Way** (Curb Ramps)

Main Street: EASTLAND\_MALL\_DR Intersection ID: 14959 Cross Street: CENTRAL\_AV Location: **Overall Compliance: No** ADA ID: 9A4C38BD7503 Ramp Type: Perp Initial Pass/Fail: Fail Severity Score: 13.75

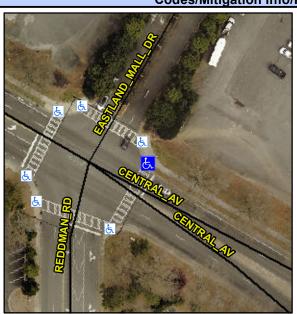
| Possible Solutions: | | | | | | |
|---|--|--|--|--|--|--|
| Not Found, R304.2.2 | | | | | | |

| Field Measurements/Component Compliance | | | | | | |
|---|---|---|---|---|---|--|
| N/A | Ramp Length (in) | 61.5 | No | Ramp Slope (%) | 10.1 | |

| Possible Solutions: | | | | | | |
|---|--|--|--|--|--|--|
| Remove & Replace Entire Ramp. | | | | | | |
