Access Compliance Report

Public Rights-of-Way

(Curb Ramps)

Intersection ID: 10038352	Main Street: SOUTH_BV	Cross Street: N/A	Location: SE
ADA ID: 9A5D6CE64724	Ramp Type: PerpDiag	Initial Pass/Fail: Fail	Overall Compliance: No
Severity Score: 22.5			
Codes/Mitigation Info/Possible Solution		Field Measurements/Component Compliance

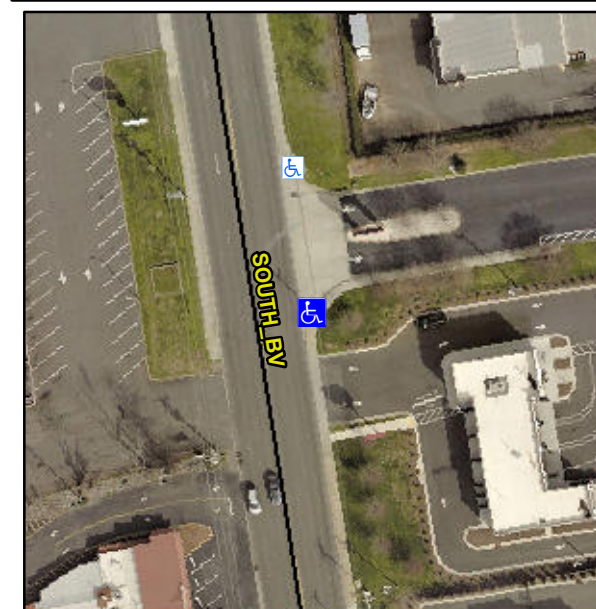
Not Found, R304.5.1, R304.2.2, R304.5.3

Compliance	Description	Data	Compliance	Description	Data
N/A	Ramp Length (in)	51.0	No	Ramp Slope (%)	9.1
No	Ramp Width (in)	38.5	No	Ramp XSlope (%)	2.2
N/A	Flare Type LT	N/A	N/A	Flare Type RT	N/A
N/A	Flare Slope LT (%)	N/A	N/A	Flare Slope RT (%)	N/A
N/A	Flare Traversable LT?	N/A	N/A	Flare Traversable RT?	N/A
N/A	Landing Length (in)	N/A	N/A	DWS Provided?	N/A
N/A	Landing Width (in)	N/A	N/A	DWS Contrast?	N/A
N/A	Landing Slope (%)	N/A	N/A	DWS Length (in)	N/A
N/A	Landing X Slope (%)	N/A	N/A	DWS Full Width?	N/A
N/A	Landing Curb? (Y/N)	N/A	N/A	DWS Offset (in)	N/A
N/A	Shared Landing?	N/A			
N/A	Gutter Ponding?	N/A	N/A	Gutter Slope (%)	N/A
N/A	Gutter Lip Ht (in)	N/A	N/A	Gutter X Slope (%)	N/A
N/A	Painted X Walk1?	No	N/A	Painted X Walk2?	No
	X Walk 1 Direction	To N		X Walk 2 Direction	To W
N/A	X Walk 1 Width (in)	N/A	N/A	X Walk 2 Width (in)	N/A
	X Walk 1 Slope (%)	1.9		X Walk 2 Slope (%)	3.7
	X Walk 1 X Slope (%)	2.0		X Walk 2 X Slope (%)	3.3

N/A	Ramp inside XWalk1?	N/A	N/A	Ramp inside XWalk2?	N/A
	Road Slope (%)	3.1	N/A	Clear Space?	N/A
	Road X Slope (%)	4.2	N/A	Clear Space to XWalk (in)	N/A
N/A	Any Obstructions?	N/A	N/A	Storm Grate/Utility Hazard?	N/A
	Obstruction Type			Storm Grate/Utility Type	
		N/A			N/A
			Yes	Surface Condition? (G/P)	Good

Remove & Replace Curb Ramp With Two New Directional Ramps or Equivalent.
