## Access Compliance Report Public Rights-of-Way (Curb Ramps)

Intersection ID: 10028234	028234 Main Street: HEDGEMORE_DR			Cross Street: N/A				Location:	S
ADA ID: 9A610C5AFF95	Ramp Ty	Ramp Type: PerpDiag			itial Pass/Fail: Pass Overall Compliance: No				12.5
Codes/Mitigation Info/Possible Solution				Field Measurements/Component Compliance					
		Possible Solutions:		Compliance Description Data			Compliance Description		Data
ARE STATES		Remove & Replace Curb Ramp	With	N/A	Ramp Length (in)	48.0	Yes	Ramp Slope (%)	7.3
250 / 1000 m		Two New Directional Ramps or Equivalent.		Yes	Ramp Width (in)	77.0	Yes	Ramp XSlope (%)	1.9
E 0 1 - 1				N/A	Flare Type LT	Sloped	N/A	Flare Type RT	N/A
				N/A	Flare Slope LT (%)	2.3	Yes	Flare Slope RT (%)	2.5
A SHE ET LA THINK	ALL AND	12.11		N/A	Flare Traversable LT?	Yes	N/A	Flare Traversable RT?	Yes
				No	Landing Length (in)	N/A	Yes	DWS Provided?	Yes
		Surveyor Notes:		No	Landing Width (in)	N/A	Yes	DWS Contrast?	Yes
B B		N/A		No	Landing Slope (%)	N/A	Yes	DWS Length (in)	24.0

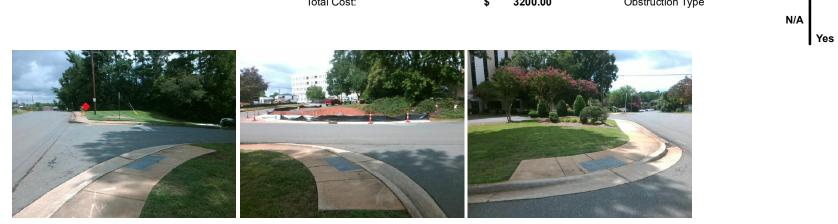
No	Landing X Slope (%)	N/A	No	DWS Full Width?	No
	New Contraction			N/A	Landing Curb? (Y/N)	No	Yes	DWS Offset (in)	2.0
				N/A	Shared Landing?	N/A			
MORANCEIRD LIN	Cardelan.	PROW/ADA:		Yes	Gutter Ponding?	No	Yes	Gutter Slope (%)	4.5
Micentific		Not Found, R304.2.1, R304.2.2	erp.	Yes	Gutter Lip Ht (in)	0.0	Yes	Gutter X Slope (%)	1.6
5		R304.3.2-Para, R304.5.3, R305.1.	• •	N/A	Painted X Walk1?	No	N/A	Painted X Walk2?	No
					X Walk 1 Direction	To N		X Walk 2 Direction	To W
	State of the second			N/A	X Walk 1 Width (in)	N/A	N/A	X Walk 2 Width (in)	N/A
Street 1 Name	ENTRANCE				X Walk 1 Slope (%)	3.7		X Walk 2 Slope (%)	3.5
Stop Condition-Street 2	StopSign				X Walk 1 X Slope (%)	1.3		X Walk 2 X Slope (%)	3.9
Street 2 Name	HEDGEMORE DR			N/A	Ramp inside XWalk1?	N/A	N/A	Ramp inside XWalk2?	N/A
Stop Condition-Street 1	None				Road Slope (%)	2.6	N/A	Clear Space?	Yes
					Road X Slope (%)	2.6	N/A	Clear Space to XWalk (in)	N/A

Yes	Any Obstructions?	No	Yes	Storm Grate/Utility Hazard?	No
		Total Cost: \$	3200.00		Obstruction Type			Storm Grate/Utility Type	
						N/A			N/A
1
