Access Compliance Report

Public Rights-of-Way

(Curb Ramps)

Intersection ID: 24499	Main Street: BECKMORE_PL	Cross Street: SAINTFIELD_PL	Location: NW
ADA ID: 9A6412862694	Ramp Type: Perp	Initial Pass/Fail: Fail	Overall Compliance: No
		Severity Score: 25

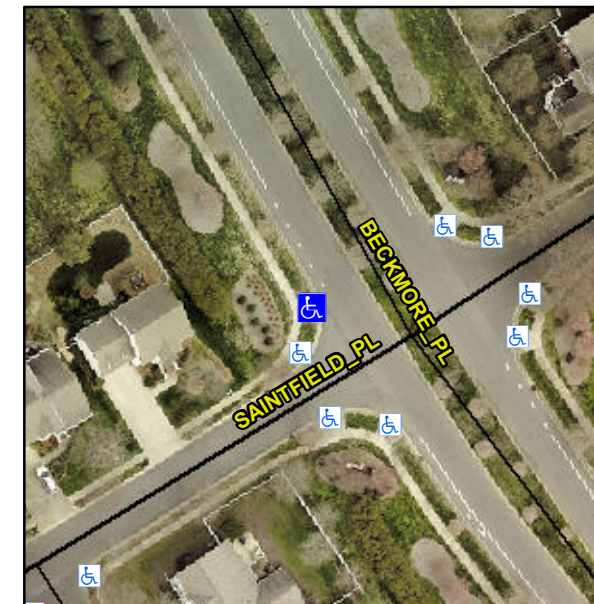
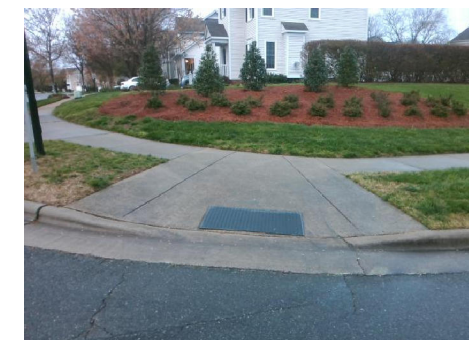
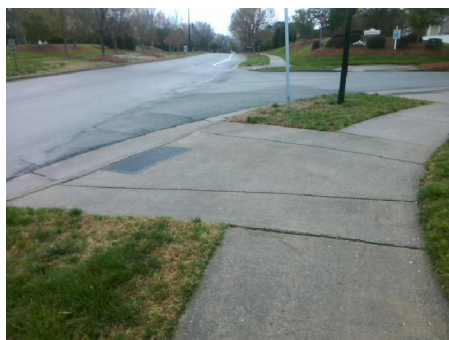
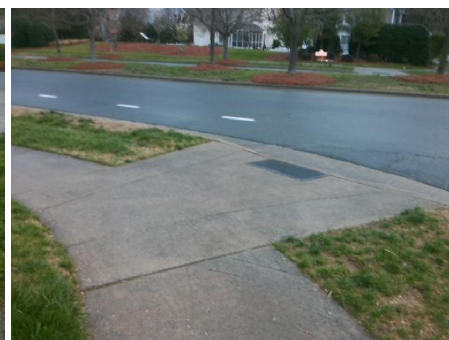
Not Found, R304.2.2, R304.5.3

Compliance	Description	Data	Compliance	Description	Data
N/A	Ramp Length (in)	94.0	No	Ramp Slope (%)	9.6
Yes	Ramp Width (in)	48.0	No	Ramp XSlope (%)	6.6
N/A	Flare Type LT	N/A	N/A	Flare Type RT	N/A
N/A	Flare Slope LT (%)	N/A	N/A	Flare Slope RT (%)	N/A
N/A	Flare Traversable LT?	N/A	N/A	Flare Traversable RT?	N/A
N/A	Landing Length (in)	N/A	N/A	DWS Provided?	N/A
N/A	Landing Width (in)	N/A	N/A	DWS Contrast?	N/A
N/A	Landing Slope (%)	N/A	N/A	DWS Length (in)	N/A
N/A	Landing X Slope (%)	N/A	N/A	DWS Full Width?	N/A
N/A	Landing Curb? (Y/N)	N/A	N/A	DWS Offset (in)	N/A
N/A	Shared Landing?	N/A			
N/A	Gutter Ponding?	N/A	N/A	Gutter Slope (%)	N/A
N/A	Gutter Lip Ht (in)	N/A	N/A	Gutter X Slope (%)	N/A
N/A	Painted X Walk1?	No	N/A	Painted X Walk2?	N/A
	X Walk 1 Direction	To E		X Walk 2 Direction	N/A
N/A	X Walk 1 Width (in)	N/A	N/A	X Walk 2 Width (in)	N/A
	X Walk 1 Slope (%)	4.2		X Walk 2 Slope (%)	N/A
	X Walk 1 X Slope (%)	3.5		X Walk 2 X Slope (%)	N/A

N/A	Ramp inside XWalk1?	N/A	N/A	Ramp inside XWalk2?	N/A
	Road Slope (%)	N/A	N/A	Clear Space?	N/A
	Road X Slope (%)	N/A	N/A	Clear Space to XWalk (in)	N/A
N/A	Any Obstructions?	N/A	N/A	Storm Grate/Utility Hazard?	N/A
	Obstruction Type			Storm Grate/Utility Type	
		N/A			N/A
			Yes	Surface Condition? (G/P)	Good

Remove & Replace Entire Ramp.
