Access Compliance Report

Public Rights-of-Way (Curb Ramps)

| Intersection ID: 29915 | Main Street: NORTHRIDGE_DR | Cross Street: WYNDHAM_HILL_DR | Location: SW |
| ADA ID: 9A697ECC975C | Ramp Type: PerpDiag | Initial Pass/Fail: Fail | Overall Compliance: No Severity Score: 21.25 |

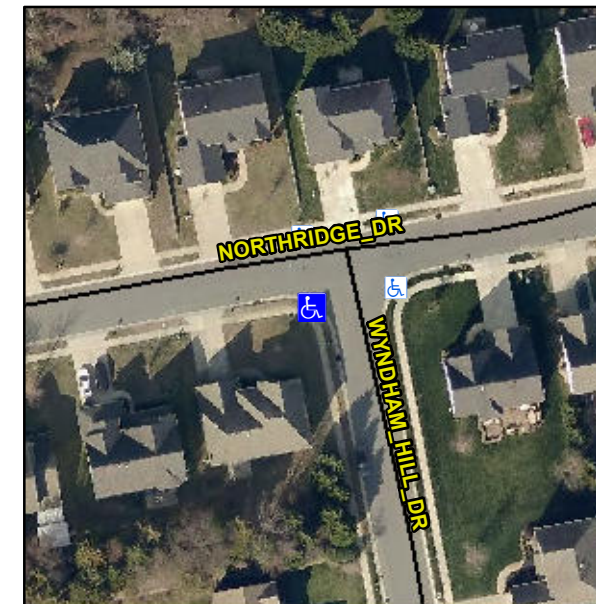
| Compliance | Description | Data | Compliance | Description | Data |
|---|---|---|---|---|---|
| No | Ramp Width (in) | 40.0 | No | Ramp XSlope (%) | 6.6 |

Remove & Replace Curb Ramp With Two New Directional Ramps or Equivalent.

R304.5.1, R304.5.3

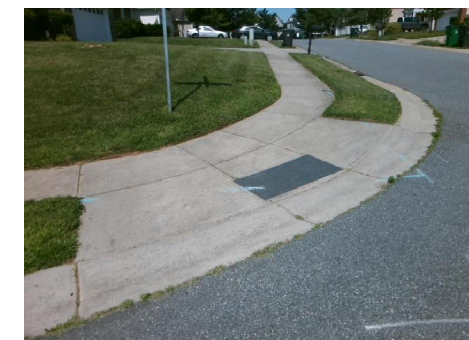
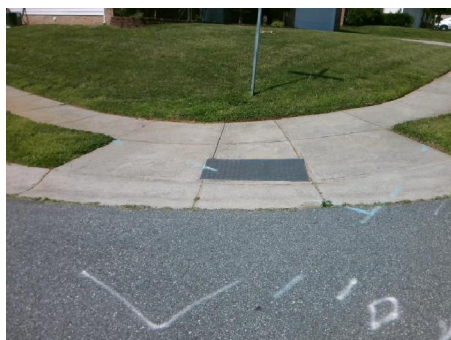
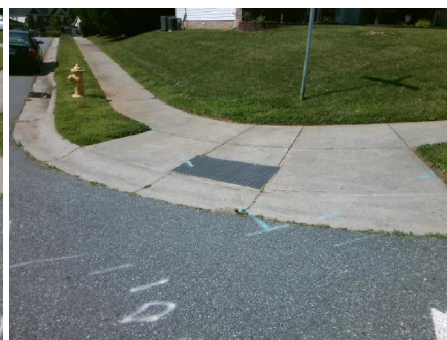
| Compliance | Description | Data | Compliance | Description | Data |
|---|---|---|---|---|---|
| | | Yes | | Surface Condition? (G/P) | Good |
