Access Compliance Report Public Rights-of-Way (Curb Ramps)

Intersection ID: 14757 Main Street: E WORTHINGTON AV **Cross Street: LENNOX AV** Location: Ν ADA ID: 9A814F16549C Ramp Type: BlendTrans1 Initial Pass/Fail: Fail **Overall Compliance: No Severity Score:** 1.25

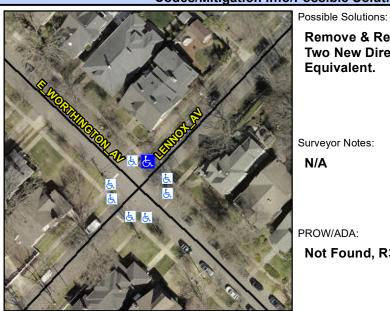
Not Found, R304.5.3

Field Measurements/Component Compliance					
Compliance Description		Data	Compliance Description		Data
N/A	Ramp Length (in)	122.0	Yes	BlendTrans Slope (%)	4.3
Yes	Ramp Width (in)	59.0	No	BlendTrans XSlope (%)	2.1
N/A	Flare Type LT	N/A	N/A	Flare Type RT	N/A
N/A	Flare Slope LT (%)	N/A	N/A	Flare Slope RT (%)	N/A
N/A	Flare Traversable LT?	N/A	N/A	Flare Traversable RT?	N/A
N/A	Landing Length (in)	N/A	N/A	DWS Provided?	N/A
N/A	Landing Width (in)	N/A	N/A	DWS Contrast?	N/A
N/A	Landing Slope (%)	N/A	N/A	DWS Length (in)	N/A
N/A	Landing X Slope (%)	N/A	N/A	DWS Full Width?	N/A
N/A	Landing Curb? (Y/N)	N/A	N/A	DWS Offset (in)	N/A
N/A	Shared Landing?	N/A			
N/A	Gutter Ponding?	N/A	N/A	Gutter Slope (%)	N/A
N/A	Gutter Lip Ht (in)	1.0	N/A	Gutter X Slope (%)	N/A
N/A	Painted X Walk1?	No	N/A	Painted X Walk2?	N/A
	X Walk 1 Direction	To SE		X Walk 2 Direction	N/A
	X Walk 1 Width (in)	N/A		X Walk 2 Width (in)	N/A
	X Walk 1 Slope (%)	0.7		X Walk 2 Slope (%)	N/A

X Walk 1 X Slope (%)	2.4		X Walk 2 X Slope (%)	N/A
N/A	Ramp inside XWalk1?	N/A	N/A	Ramp inside XWalk2?	N/A
	Road Slope (%)	2.4		Clear Space?	N/A
	Road X Slope (%)	0.7	N/A	Clear Space to XWalk (in)	N/A
N/A	Any Obstructions?	N/A	N/A	Storm Grate/Utility Hazard?	N/A
	Obstruction Type			Storm Grate/Utility Type	
		N/A			N/A
			Yes	Surface Condition? (G/P)	Good
	A Part of the Control		No	Curb Slope (%)	10.3

LENNOX AV Street 1 Name StopSign Stop Condition-Street 1 Street 2 Name N/A Stop Condition-Street 2 N/A **Remove & Replace Curb Ramp With** Two New Directional Ramps or Equivalent.

3200.00
