Access Compliance Report

Public Rights-of-Way

(Curb Ramps)

| Intersection ID: 48140 | Main Street: MCCAMEY_DR | Cross Street: BUTTERBURR_DR | Location: SW |

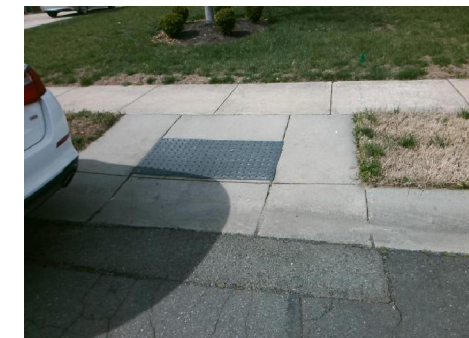
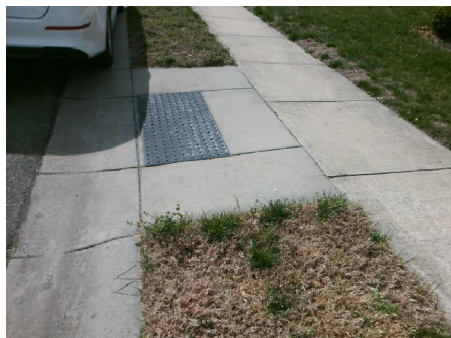
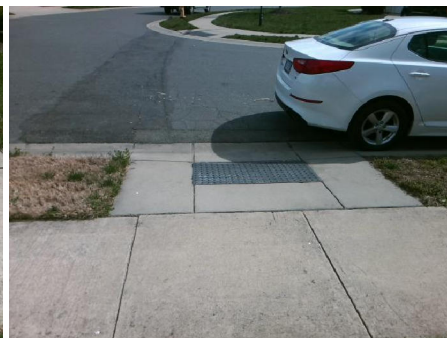
| ADA ID: 9A81AB81712A | Ramp Type: Perp | Initial Pass/Fail: Fail | Overall Compliance: No |

Not Found, R304.2.2

| Compliance | Description | Data | Compliance | Description | Data |
|---|---|---|---|---|---|
| N/A | Ramp Length (in) | 47.5 | No | Ramp Slope (%) | 13.8 |

Remove & Replace Entire Ramp.
