Access Compliance Report

Public Rights-of-Way

(Curb Ramps)

Intersection ID: 20645	Main Street: NEWHALL_RD	Cross Street: WINGRAVE_DR	Location: SW
ADA ID: 9A85E3026388	Ramp Type: PerpDiag	Initial Pass/Fail: Fail	Overall Compliance: No
Codes/Mitigation Info/Possible Solution		Field Measurements/Component Compliance

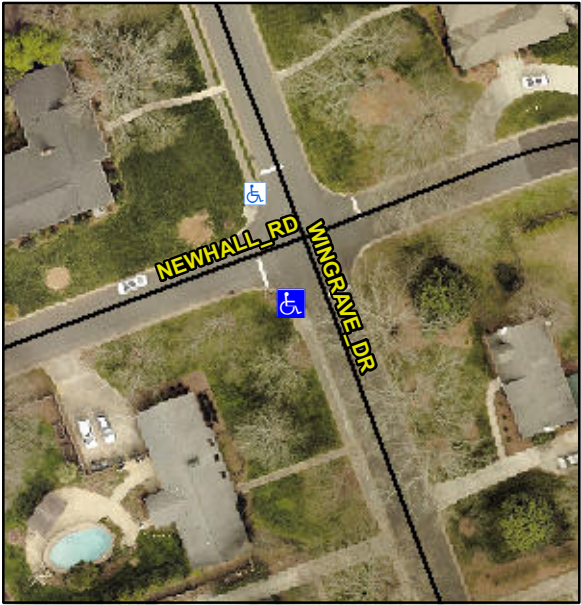
Possible Solutions:						
	Remove & Replace Curb Ramp With Two New Directional Ramps or Equivalent.						
<p>Surveyor Notes:</p> <p>N/A</p>	<p>PROW/ADA:</p> <p>Not Found, R304.5.3</p>	Compliance	Description	Data	Compliance	Description	Data
		N/A	Ramp Length (in)	60.0	Yes	Ramp Slope (%)	6.1
		Yes	Ramp Width (in)	48.0	No	Ramp XSlope (%)	3.6
		N/A	Flare Type LT	N/A	N/A	Flare Type RT	N/A
		N/A	Flare Slope LT (%)	N/A	N/A	Flare Slope RT (%)	N/A
		N/A	Flare Traversable LT?	N/A	N/A	Flare Traversable RT?	N/A
		N/A	Landing Length (in)	N/A	N/A	DWS Provided?	N/A
		N/A	Landing Width (in)	N/A	N/A	DWS Contrast?	N/A
		N/A	Landing Slope (%)	N/A	N/A	DWS Length (in)	N/A
		N/A	Landing X Slope (%)	N/A	N/A	DWS Full Width?	N/A
		N/A	Landing Curb? (Y/N)	N/A	N/A	DWS Offset (in)	N/A
		N/A	Shared Landing?	N/A			
		N/A	Gutter Ponding?	N/A	N/A	Gutter Slope (%)	N/A
		N/A	Gutter Lip Ht (in)	N/A	N/A	Gutter X Slope (%)	N/A
		N/A	Painted X Walk1?	No	N/A	Painted X Walk2?	No

X Walk 1 Direction	To E		X Walk 2 Direction	To N
		N/A	X Walk 1 Width (in)	N/A	N/A	X Walk 2 Width (in)	N/A
			X Walk 1 Slope (%)	3.0		X Walk 2 Slope (%)	4.8
			X Walk 1 X Slope (%)	4.1		X Walk 2 X Slope (%)	1.3
		N/A	Ramp inside XWalk1?	N/A	N/A	Ramp inside XWalk2?	N/A
			Road Slope (%)	1.2	N/A	Clear Space?	N/A
			Road X Slope (%)	11.3	N/A	Clear Space to XWalk (in)	N/A
		N/A	Any Obstructions?	N/A	N/A	Storm Grate/Utility Hazard?	N/A
			Obstruction Type			Storm Grate/Utility Type	
					N/A		N/A
					Yes	Surface Condition? (G/P)	Good
