# Access Compliance Report

## Public Rights-of-Way

### (Curb Ramps)

Intersection ID: 10026315	Main Street: FAIRVIEW_RD	Cross Street: N/A	Location: SE
ADA ID: 9A8705859878	Ramp Type: PerpDiag	Initial Pass/Fail: Fail	Overall Compliance: No
Codes/Mitigation Info/Possible Solution		Field Measurements/Component Compliance	
Severity Score: 55

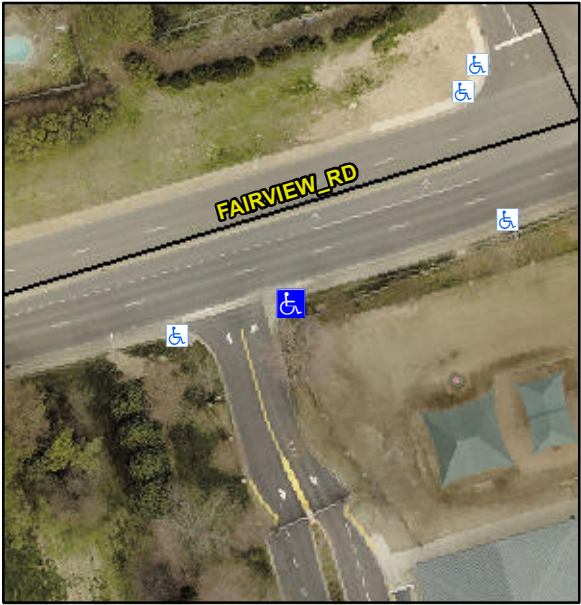
Possible Solutions:	Compliance	Description	Data	Compliance	Description	Data
	Remove & Replace Curb Ramp With Two New Directional Ramps or Equivalent.	N/A	Ramp Length (in)	46.0	No	Ramp Slope (%)	12.3
		No	Ramp Width (in)	32.0	No	Ramp XSlope (%)	6.1
		N/A	Flare Type LT	N/A	N/A	Flare Type RT	N/A
		N/A	Flare Slope LT (%)	N/A	N/A	Flare Slope RT (%)	N/A
		N/A	Flare Traversable LT?	N/A	N/A	Flare Traversable RT?	N/A
		N/A	Landing Length (in)	N/A	N/A	DWS Provided?	N/A
		N/A	Landing Width (in)	N/A	N/A	DWS Contrast?	N/A
		N/A	Landing Slope (%)	N/A	N/A	DWS Length (in)	N/A
		N/A	Landing X Slope (%)	N/A	N/A	DWS Full Width?	N/A
<p>Surveyor Notes:</p> <p>N/A</p> <p>PROW/ADA:</p> <p>Not Found, R304.5.1, R304.2.2, R304.5.3</p>		N/A	Landing Curb? (Y/N)	N/A	N/A	DWS Offset (in)	N/A
		N/A	Shared Landing?	N/A			
		N/A	Gutter Ponding?	N/A	N/A	Gutter Slope (%)	N/A
		N/A	Gutter Lip Ht (in)	N/A	N/A	Gutter X Slope (%)	N/A
		N/A	Painted X Walk1?	No	N/A	Painted X Walk2?	No

X Walk 1 Direction	To N		X Walk 2 Direction	To W
		N/A	X Walk 1 Width (in)	N/A	N/A	X Walk 2 Width (in)	N/A
			X Walk 1 Slope (%)	0.3		X Walk 2 Slope (%)	3.3
			X Walk 1 X Slope (%)	4.6		X Walk 2 X Slope (%)	5.8
		N/A	Ramp inside XWalk1?	N/A	N/A	Ramp inside XWalk2?	N/A
<p>Street 1 Name</p> <p>Stop Condition-Street 2</p> <p>Street 2 Name</p> <p>Stop Condition-Street 1</p>			Road Slope (%)	3.6	N/A	Clear Space?	N/A
			Road X Slope (%)	5.9	N/A	Clear Space to XWalk (in)	N/A
		N/A	Any Obstructions?	N/A	N/A	Storm Grate/Utility Hazard?	N/A
			Obstruction Type			Storm Grate/Utility Type	
					N/A		N/A
					Yes	Surface Condition? (G/P)	Good
Total Cost:		\$	3200.00
