Access Compliance Report

Public Rights-of-Way

(Curb Ramps)

Intersection ID: 5025	Main Street: CLARENCEFIELD_DR	Cross Street: PENNYCROSS_LN	Location: S
ADA ID: 9A907845BE6E	Ramp Type: BlendTrans2	Initial Pass/Fail: Fail	Overall Compliance: No
		Severity Score: 25

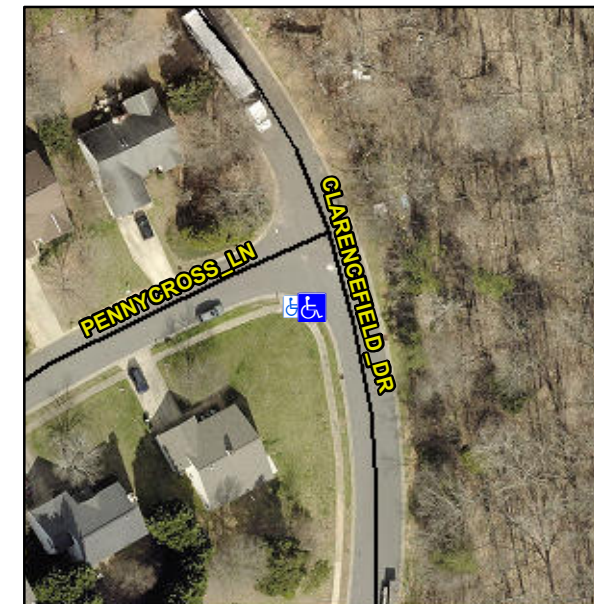
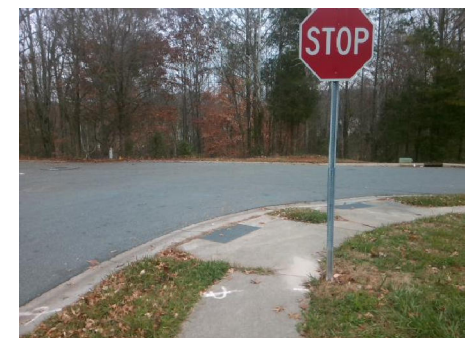
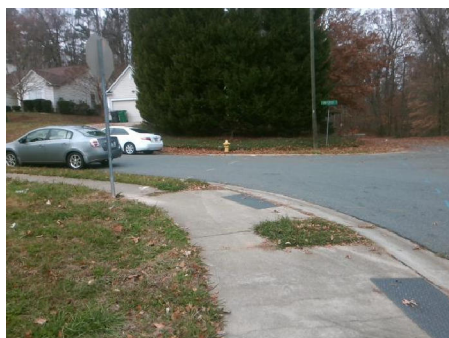
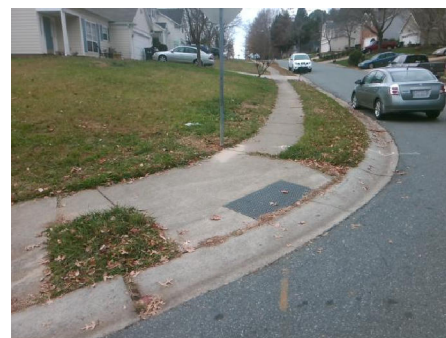
Not Found, R304.5.3

Compliance	Description	Data	Compliance	Description	Data
N/A	Ramp Length (in)	95.0	Yes	BlendTrans Slope (%)	3.7
Yes	Ramp Width (in)	48.0	No	BlendTrans XSlope (%)	7.1
N/A	Flare Type LT	N/A	N/A	Flare Type RT	N/A
N/A	Flare Slope LT (%)	N/A	N/A	Flare Slope RT (%)	N/A
N/A	Flare Traversable LT?	N/A	N/A	Flare Traversable RT?	N/A
N/A	Landing Length (in)	N/A	N/A	DWS Provided?	N/A
N/A	Landing Width (in)	N/A	N/A	DWS Contrast?	N/A
N/A	Landing Slope (%)	N/A	N/A	DWS Length (in)	N/A
N/A	Landing X Slope (%)	N/A	N/A	DWS Full Width?	N/A
N/A	Landing Curb? (Y/N)	N/A	N/A	DWS Offset (in)	N/A
N/A	Shared Landing?	N/A			
N/A	Gutter Ponding?	N/A	N/A	Gutter Slope (%)	N/A
N/A	Gutter Lip Ht (in)	N/A	N/A	Gutter X Slope (%)	N/A
N/A	Painted X Walk1?	No	N/A	Painted X Walk2?	N/A
	X Walk 1 Direction	To E		X Walk 2 Direction	N/A
	X Walk 1 Width (in)	N/A		X Walk 2 Width (in)	N/A
	X Walk 1 Slope (%)	1.4		X Walk 2 Slope (%)	N/A
	X Walk 1 X Slope (%)	3.9		X Walk 2 X Slope (%)	N/A

N/A	Ramp inside XWalk1?	N/A	N/A	Ramp inside XWalk2?	N/A
	Road Slope (%)	3.9		Clear Space?	N/A
	Road X Slope (%)	1.4	N/A	Clear Space to XWalk (in)	N/A
N/A	Any Obstructions?	N/A	N/A	Storm Grate/Utility Hazard?	N/A
	Obstruction Type			Storm Grate/Utility Type	
		N/A			N/A
			Yes	Surface Condition? (G/P)	Good
			No	Curb Slope (%)	15.4

Remove & Replace Curb Ramp With Two New Directional Ramps or Equivalent.
