# Access Compliance Report

## Public Rights-of-Way

### (Curb Ramps)

Intersection ID: 49702	Main Street: SCOTTSMAN_TRACE_DR	Cross Street: MILL_RIVER_LN	Location: NE
ADA ID: 9A926A22D9A3	Ramp Type: BlendTrans1	Initial Pass/Fail: Fail	Overall Compliance: No
Codes/Mitigation Info/Possible Solution		Field Measurements/Component Compliance	
Severity Score: 8.75

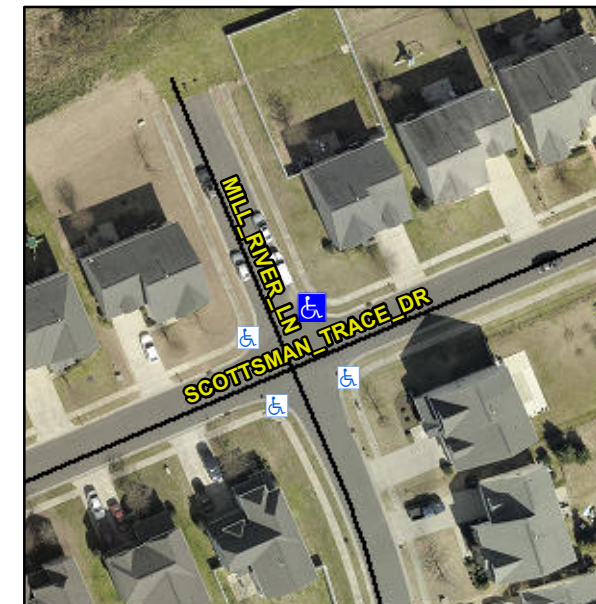
**Not Found, R304.5.1**

Compliance	Description	Data	Compliance	Description	Data
N/A	Ramp Length (in)	48.0	Yes	BlendTrans Slope (%)	3.7
No	Ramp Width (in)	45.0	Yes	BlendTrans XSlope (%)	1.8
N/A	Flare Type LT	N/A	N/A	Flare Type RT	N/A
N/A	Flare Slope LT (%)	N/A	N/A	Flare Slope RT (%)	N/A
N/A	Flare Traversable LT?	N/A	N/A	Flare Traversable RT?	N/A
N/A	Landing Length (in)	N/A	N/A	DWS Provided?	N/A
N/A	Landing Width (in)	N/A	N/A	DWS Contrast?	N/A
N/A	Landing Slope (%)	N/A	N/A	DWS Length (in)	N/A
N/A	Landing X Slope (%)	N/A	N/A	DWS Full Width?	N/A
N/A	Landing Curb? (Y/N)	N/A	N/A	DWS Offset (in)	N/A
N/A	Shared Landing?	N/A			
N/A	Gutter Ponding?	N/A	N/A	Gutter Slope (%)	N/A
N/A	Gutter Lip Ht (in)	N/A	N/A	Gutter X Slope (%)	N/A
N/A	Painted X Walk1?	No	N/A	Painted X Walk2?	No
	X Walk 1 Direction	To SW		X Walk 2 Direction	To SE
	X Walk 1 Width (in)	N/A		X Walk 2 Width (in)	N/A
	X Walk 1 Slope (%)	1.2		X Walk 2 Slope (%)	3.6
	X Walk 1 X Slope (%)	0.8		X Walk 2 X Slope (%)	3.1

N/A	Ramp inside XWalk1?	N/A	N/A	Ramp inside XWalk2?	N/A
	Road Slope (%)	3.6		Clear Space?	N/A
	Road X Slope (%)	2.0	N/A	Clear Space to XWalk (in)	N/A
N/A	Any Obstructions?	N/A	N/A	Storm Grate/Utility Hazard?	N/A
	Obstruction Type			Storm Grate/Utility Type	
		N/A			N/A
			Yes	Surface Condition? (G/P)	Good
			No	Curb Slope (%)	9.3

**Remove & Replace Curb Ramp With Two New Directional Ramps or Equivalent.**
