Access Compliance Report

Public Rights-of-Way

(Curb Ramps)

Intersection ID: 2913	Main Street: CREEK_BREEZE_RD	Cross Street: MEADOWVIEW_HILLS_DR	Location: SW
ADA ID: 9A9BFF5AE0DF	Ramp Type: PerpDiag	Initial Pass/Fail: Fail	Overall Compliance: No
Severity Score: 13.75			
Codes/Mitigation Info/Possible Solution		Field Measurements/Component Compliance

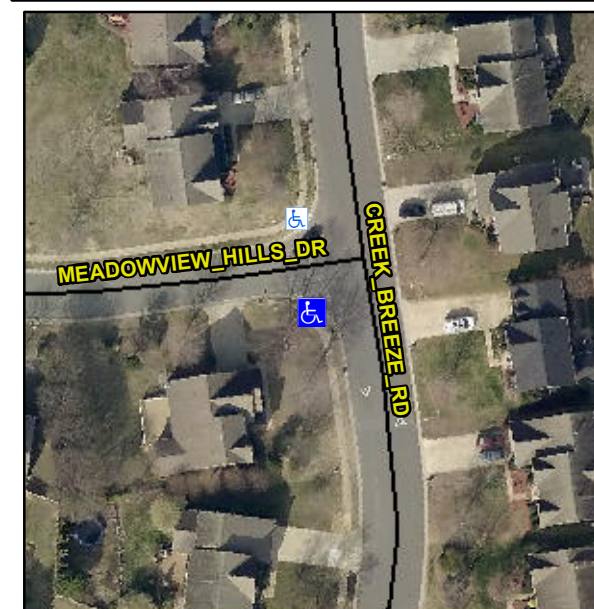
R304.2.2, R304.5.3

Compliance	Description	Data	Compliance	Description	Data
N/A	Ramp Length (in)	43.0	No	Ramp Slope (%)	11.2
Yes	Ramp Width (in)	56.0	No	Ramp XSlope (%)	4.1
N/A	Flare Type LT	N/A	N/A	Flare Type RT	N/A
N/A	Flare Slope LT (%)	N/A	N/A	Flare Slope RT (%)	N/A
N/A	Flare Traversable LT?	N/A	N/A	Flare Traversable RT?	N/A
N/A	Landing Length (in)	N/A	N/A	DWS Provided?	N/A
N/A	Landing Width (in)	N/A	N/A	DWS Contrast?	N/A
N/A	Landing Slope (%)	N/A	N/A	DWS Length (in)	N/A
N/A	Landing X Slope (%)	N/A	N/A	DWS Full Width?	N/A
N/A	Landing Curb? (Y/N)	N/A	N/A	DWS Offset (in)	N/A
N/A	Shared Landing?	N/A			
N/A	Gutter Ponding?	N/A	N/A	Gutter Slope (%)	N/A
N/A	Gutter Lip Ht (in)	N/A	N/A	Gutter X Slope (%)	N/A
N/A	Painted X Walk1?	No	N/A	Painted X Walk2?	No
	X Walk 1 Direction	To E		X Walk 2 Direction	To N
N/A	X Walk 1 Width (in)	N/A	N/A	X Walk 2 Width (in)	N/A
	X Walk 1 Slope (%)	6.6		X Walk 2 Slope (%)	5.9
	X Walk 1 X Slope (%)	3.2		X Walk 2 X Slope (%)	2.5

N/A	Ramp inside XWalk1?	N/A	N/A	Ramp inside XWalk2?	N/A
	Road Slope (%)	5.6	N/A	Clear Space?	N/A
	Road X Slope (%)	2.4	N/A	Clear Space to XWalk (in)	N/A
N/A	Any Obstructions?	N/A	N/A	Storm Grate/Utility Hazard?	N/A
	Obstruction Type			Storm Grate/Utility Type	
		N/A			N/A
		Yes		Surface Condition? (G/P)	Good

Remove & Replace Curb Ramp With Two New Directional Ramps or Equivalent.
