# Access Compliance Report

## Public Rights-of-Way

### (Curb Ramps)

Intersection ID: 13985	Main Street: CAMDEN_RD	Cross Street: EAST_BV	Location: SE
ADA ID: 9AAFD0896423	Ramp Type: Perp	Initial Pass/Fail: Fail	Overall Compliance: No
Codes/Mitigation Info/Possible Solution		Field Measurements/Component Compliance	
Severity Score: 13.75

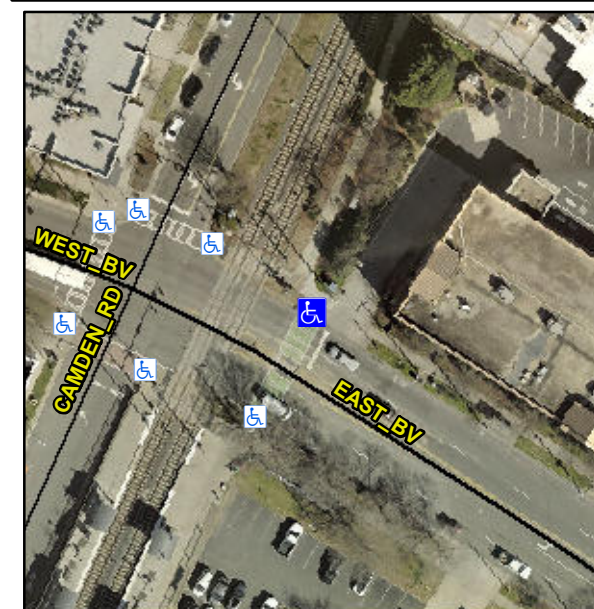
Compliance	Description	Data	Compliance	Description	Data
N/A	Ramp Length (in)	78.0	No	Ramp Slope (%)	8.9
Yes	Ramp Width (in)	98.0	No	Ramp XSlope (%)	2.8
N/A	Flare Type LT	N/A	N/A	Flare Type RT	N/A
N/A	Flare Slope LT (%)	N/A	N/A	Flare Slope RT (%)	N/A
N/A	Flare Traversable LT?	N/A	N/A	Flare Traversable RT?	N/A
N/A	Landing Length (in)	N/A	N/A	DWS Provided?	N/A
N/A	Landing Width (in)	N/A	N/A	DWS Contrast?	N/A
N/A	Landing Slope (%)	N/A	N/A	DWS Length (in)	N/A
N/A	Landing X Slope (%)	N/A	N/A	DWS Full Width?	N/A
N/A	Landing Curb? (Y/N)	N/A	N/A	DWS Offset (in)	N/A
N/A	Shared Landing?	N/A			
N/A	Gutter Ponding?	N/A	N/A	Gutter Slope (%)	N/A
N/A	Gutter Lip Ht (in)	N/A	N/A	Gutter X Slope (%)	N/A
N/A	Painted X Walk1?	Yes	N/A	Painted X Walk2?	N/A
	X Walk 1 Direction	To SW		X Walk 2 Direction	N/A
N/A	X Walk 1 Width (in)	144.0	N/A	X Walk 2 Width (in)	N/A
	X Walk 1 Slope (%)	2.9		X Walk 2 Slope (%)	N/A
	X Walk 1 X Slope (%)	0.7		X Walk 2 X Slope (%)	N/A

N/A	Ramp inside XWalk1?	Yes	N/A	Ramp inside XWalk2?	N/A
	Road Slope (%)	N/A	N/A	Clear Space?	N/A
	Road X Slope (%)	N/A	N/A	Clear Space to XWalk (in)	N/A
N/A	Any Obstructions?	N/A	N/A	Storm Grate/Utility Hazard?	N/A
	Obstruction Type			Storm Grate/Utility Type	
		N/A			N/A
			Yes	Surface Condition? (G/P)	Good

**Remove & Replace Entire Ramp.**

**R304.2.2, R304.5.3**
