Access Compliance Report

Public Rights-of-Way

(Curb Ramps)

Intersection ID: 43685	Main Street: HARLINGTON_LN	Cross Street: TODDINGTON_LN	Location: SW
ADA ID: 9AB5833549F2	Ramp Type: PerpDiag	Initial Pass/Fail: Fail	Overall Compliance: No
Severity Score: 10			
Codes/Mitigation Info/Possible Solution		Field Measurements/Component Compliance

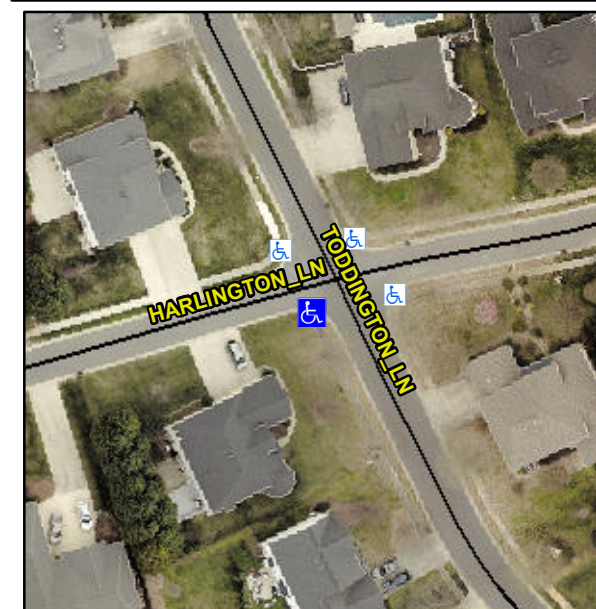
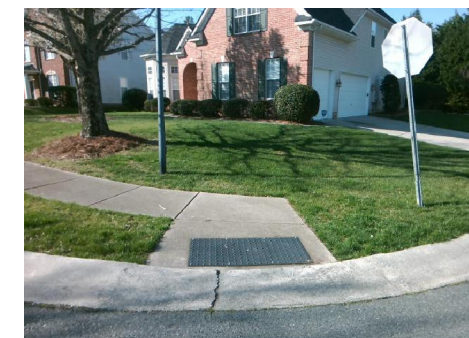
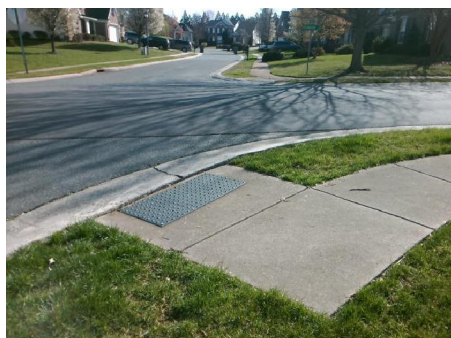
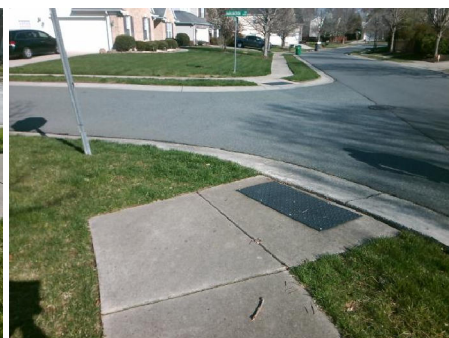
Not Found, R304.5.1, R304.5.3

Compliance	Description	Data	Compliance	Description	Data
N/A	Ramp Length (in)	43.0	Yes	Ramp Slope (%)	5.6
No	Ramp Width (in)	47.0	No	Ramp XSlope (%)	4.1
N/A	Flare Type LT	N/A	N/A	Flare Type RT	N/A
N/A	Flare Slope LT (%)	N/A	N/A	Flare Slope RT (%)	N/A
N/A	Flare Traversable LT?	N/A	N/A	Flare Traversable RT?	N/A
N/A	Landing Length (in)	N/A	N/A	DWS Provided?	N/A
N/A	Landing Width (in)	N/A	N/A	DWS Contrast?	N/A
N/A	Landing Slope (%)	N/A	N/A	DWS Length (in)	N/A
N/A	Landing X Slope (%)	N/A	N/A	DWS Full Width?	N/A
N/A	Landing Curb? (Y/N)	N/A	N/A	DWS Offset (in)	N/A
N/A	Shared Landing?	N/A			
N/A	Gutter Ponding?	N/A	N/A	Gutter Slope (%)	N/A
N/A	Gutter Lip Ht (in)	N/A	N/A	Gutter X Slope (%)	N/A
N/A	Painted X Walk1?	No	N/A	Painted X Walk2?	No
	X Walk 1 Direction	To E		X Walk 2 Direction	To N
N/A	X Walk 1 Width (in)	N/A	N/A	X Walk 2 Width (in)	N/A
	X Walk 1 Slope (%)	3.7		X Walk 2 Slope (%)	0.8
	X Walk 1 X Slope (%)	0.8		X Walk 2 X Slope (%)	2.4

N/A	Ramp inside XWalk1?	N/A	N/A	Ramp inside XWalk2?	N/A
	Road Slope (%)	3.3	N/A	Clear Space?	N/A
	Road X Slope (%)	0.7	N/A	Clear Space to XWalk (in)	N/A
N/A	Any Obstructions?	N/A	N/A	Storm Grate/Utility Hazard?	N/A
	Obstruction Type			Storm Grate/Utility Type	
		N/A			N/A
		Yes		Surface Condition? (G/P)	Good

Remove & Replace Curb Ramp With Two New Directional Ramps or Equivalent.
