Access Compliance Report

Public Rights-of-Way

(Curb Ramps)

Intersection ID: 4697	Main Street: BELLA_VISTA_CT	Cross Street: REAMES_RD	Location: SW
ADA ID: 9ACD5E61C57E	Ramp Type: Perp	Initial Pass/Fail: Fail	Overall Compliance: No
Severity Score: 31.25			
Codes/Mitigation Info/Possible Solution		Field Measurements/Component Compliance

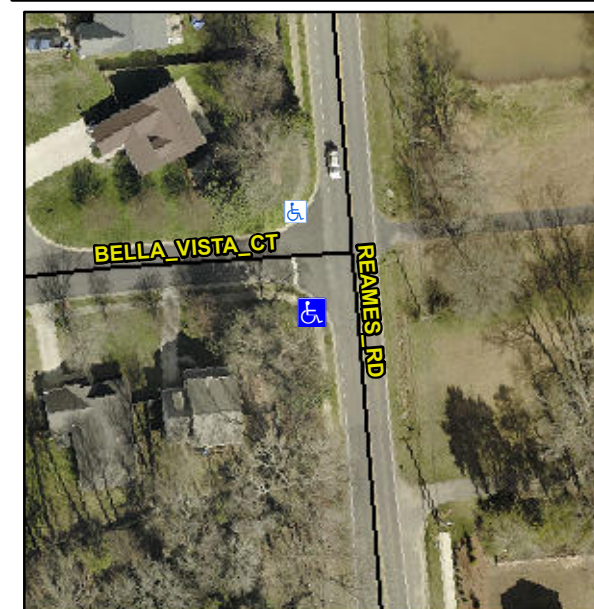
Not Found, R304.5.1, R304.2.2, R304.5.3

Compliance	Description	Data	Compliance	Description	Data
N/A	Ramp Length (in)	24.8	No	Ramp Slope (%)	8.6
No	Ramp Width (in)	34.0	No	Ramp XSlope (%)	4.0
N/A	Flare Type LT	N/A	N/A	Flare Type RT	N/A
N/A	Flare Slope LT (%)	N/A	N/A	Flare Slope RT (%)	N/A
N/A	Flare Traversable LT?	N/A	N/A	Flare Traversable RT?	N/A
N/A	Landing Length (in)	N/A	N/A	DWS Provided?	N/A
N/A	Landing Width (in)	N/A	N/A	DWS Contrast?	N/A
N/A	Landing Slope (%)	N/A	N/A	DWS Length (in)	N/A
N/A	Landing X Slope (%)	N/A	N/A	DWS Full Width?	N/A
N/A	Landing Curb? (Y/N)	N/A	N/A	DWS Offset (in)	N/A
N/A	Shared Landing?	N/A			
N/A	Gutter Ponding?	N/A	N/A	Gutter Slope (%)	N/A
N/A	Gutter Lip Ht (in)	N/A	N/A	Gutter X Slope (%)	N/A
N/A	Painted X Walk1?	No	N/A	Painted X Walk2?	N/A
	X Walk 1 Direction	To NW		X Walk 2 Direction	N/A
N/A	X Walk 1 Width (in)	N/A	N/A	X Walk 2 Width (in)	N/A
	X Walk 1 Slope (%)	1.9		X Walk 2 Slope (%)	N/A
	X Walk 1 X Slope (%)	4.4		X Walk 2 X Slope (%)	N/A

N/A	Ramp inside XWalk1?	N/A	N/A	Ramp inside XWalk2?	N/A
	Road Slope (%)	N/A	N/A	Clear Space?	N/A
	Road X Slope (%)	N/A	N/A	Clear Space to XWalk (in)	N/A
N/A	Any Obstructions?	N/A	N/A	Storm Grate/Utility Hazard?	N/A
	Obstruction Type			Storm Grate/Utility Type	
		N/A			N/A
			Yes	Surface Condition? (G/P)	Good

Remove & Replace Entire Ramp.
