# Access Compliance Report

## Public Rights-of-Way

### (Curb Ramps)

Intersection ID: 14267	Main Street: CLANTON_RD	Cross Street: FARMER_ST	Location: NW
ADA ID: 9AEC850B67AB	Ramp Type: Perp	Initial Pass/Fail: Fail	Overall Compliance: No
			Severity Score: 26.25

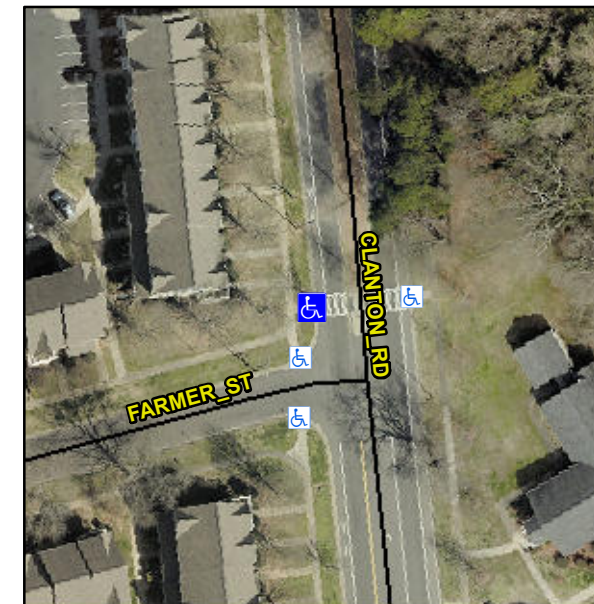
**R304.2.2, R304.5.3**

Compliance	Description	Data	Compliance	Description	Data
N/A	Ramp Length (in)	62.0	No	Ramp Slope (%)	13.2
Yes	Ramp Width (in)	48.0	No	Ramp XSlope (%)	4.9
N/A	Flare Type LT	N/A	N/A	Flare Type RT	N/A
N/A	Flare Slope LT (%)	N/A	N/A	Flare Slope RT (%)	N/A
N/A	Flare Traversable LT?	N/A	N/A	Flare Traversable RT?	N/A
N/A	Landing Length (in)	N/A	N/A	DWS Provided?	N/A
N/A	Landing Width (in)	N/A	N/A	DWS Contrast?	N/A
N/A	Landing Slope (%)	N/A	N/A	DWS Length (in)	N/A
N/A	Landing X Slope (%)	N/A	N/A	DWS Full Width?	N/A
N/A	Landing Curb? (Y/N)	N/A	N/A	DWS Offset (in)	N/A
N/A	Shared Landing?	N/A			
N/A	Gutter Ponding?	N/A	N/A	Gutter Slope (%)	N/A
N/A	Gutter Lip Ht (in)	N/A	N/A	Gutter X Slope (%)	N/A
N/A	Painted X Walk1?	Yes	N/A	Painted X Walk2?	N/A
	X Walk 1 Direction	To E		X Walk 2 Direction	N/A
N/A	X Walk 1 Width (in)	117.0	N/A	X Walk 2 Width (in)	N/A
	X Walk 1 Slope (%)	5.8		X Walk 2 Slope (%)	N/A
	X Walk 1 X Slope (%)	4.7		X Walk 2 X Slope (%)	N/A

N/A	Ramp inside XWalk1?	Yes	N/A	Ramp inside XWalk2?	N/A
	Road Slope (%)	N/A	N/A	Clear Space?	N/A
	Road X Slope (%)	N/A	N/A	Clear Space to XWalk (in)	N/A
N/A	Any Obstructions?	N/A	N/A	Storm Grate/Utility Hazard?	N/A
	Obstruction Type			Storm Grate/Utility Type	
		N/A			N/A
			Yes	Surface Condition? (G/P)	Good

**Remove & Replace Entire Ramp.**
