Access Compliance Report

Public Rights-of-Way

(Curb Ramps)

Intersection ID: 10021845	Main Street: BRIXHAM_HILL_AV	Cross Street: N/A	Location: N
ADA ID: 9AF0FF508720	Ramp Type: Perp	Initial Pass/Fail: Fail	Overall Compliance: No
Severity Score: 12.5			
Codes/Mitigation Info/Possible Solution		Field Measurements/Component Compliance

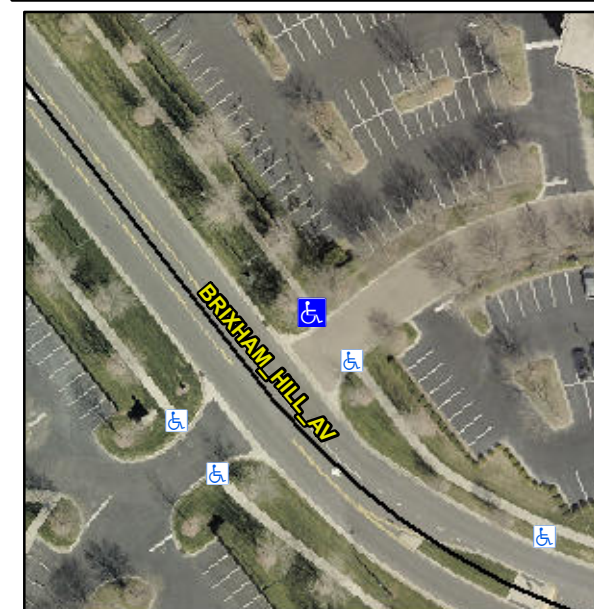
Not Found, R304.2.2

Compliance	Description	Data	Compliance	Description	Data
N/A	Ramp Length (in)	71.0	No	Ramp Slope (%)	9.1
Yes	Ramp Width (in)	58.0	Yes	Ramp XSlope (%)	0.8
N/A	Flare Type LT	N/A	N/A	Flare Type RT	N/A
N/A	Flare Slope LT (%)	N/A	N/A	Flare Slope RT (%)	N/A
N/A	Flare Traversable LT?	N/A	N/A	Flare Traversable RT?	N/A
N/A	Landing Length (in)	N/A	N/A	DWS Provided?	N/A
N/A	Landing Width (in)	N/A	N/A	DWS Contrast?	N/A
N/A	Landing Slope (%)	N/A	N/A	DWS Length (in)	N/A
N/A	Landing X Slope (%)	N/A	N/A	DWS Full Width?	N/A
N/A	Landing Curb? (Y/N)	N/A	N/A	DWS Offset (in)	N/A
N/A	Shared Landing?	N/A			
N/A	Gutter Ponding?	N/A	N/A	Gutter Slope (%)	N/A
N/A	Gutter Lip Ht (in)	N/A	N/A	Gutter X Slope (%)	N/A
N/A	Painted X Walk1?	No	N/A	Painted X Walk2?	N/A
	X Walk 1 Direction	To SE		X Walk 2 Direction	N/A
N/A	X Walk 1 Width (in)	N/A	N/A	X Walk 2 Width (in)	N/A
	X Walk 1 Slope (%)	0.9		X Walk 2 Slope (%)	N/A
	X Walk 1 X Slope (%)	4.6		X Walk 2 X Slope (%)	N/A

N/A	Ramp inside XWalk1?	N/A	N/A	Ramp inside XWalk2?	N/A
	Road Slope (%)	N/A	N/A	Clear Space?	N/A
	Road X Slope (%)	N/A	N/A	Clear Space to XWalk (in)	N/A
N/A	Any Obstructions?	N/A	N/A	Storm Grate/Utility Hazard?	N/A
	Obstruction Type			Storm Grate/Utility Type	
		N/A			N/A
			Yes	Surface Condition? (G/P)	Good

Possible Solutions:

Remove & Replace Entire Ramp.

Total Cost: \$ 1850.00
