# Access Compliance Report

## Public Rights-of-Way (Curb Ramps)

Intersection ID: 10015778	Main Street: FESTIVAL_WY	Cross Street: CRESSWIND BV	Location: N
ADA ID: 9AF549925FF0	Ramp Type: Perp	Initial Pass/Fail: Fail	Overall Compliance: No
		Severity Score: 1.25

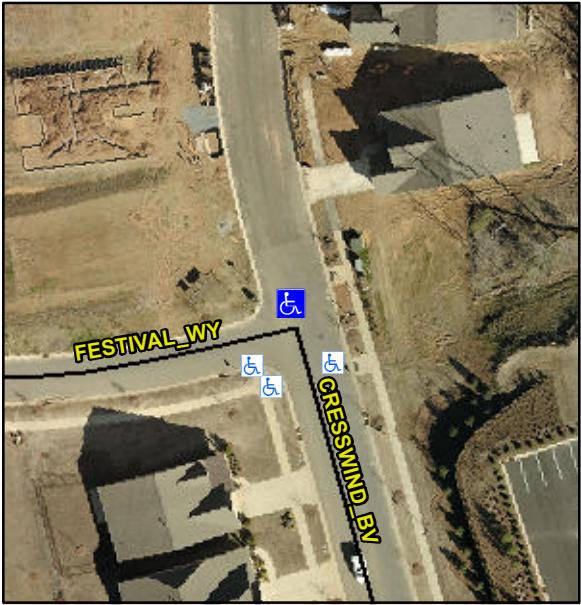
Codes/Mitigation Info/Possible Solution			Field Measurements/Component Compliance

Possible Solutions:		<b>Compliance</b>	<b>Description</b>	<b>Data</b>
	<b>Remove &amp; Replace Entire Ramp.</b>		<b>Yes</b>	Ramp Length (in)	97.0
			<b>No</b>	Ramp Width (in)	59.0
			<b>N/A</b>	Flare Type LT	N/A
			<b>N/A</b>	Flare Slope LT (%)	N/A
			<b>N/A</b>	Flare Traversable LT?	No
			<b>N/A</b>	Landing Length (in)	N/A
			<b>N/A</b>	Landing Width (in)	N/A
			<b>N/A</b>	Landing Slope (%)	N/A
			<b>N/A</b>	Landing X Slope (%)	N/A
<p>Surveyor Notes:</p> <p><b>N/A</b></p> <p>PROW/ADA:</p> <p><b>R304.5.3</b></p>			<b>N/A</b>	Flare Type RT	N/A
			<b>N/A</b>	Flare Slope RT (%)	N/A
			<b>N/A</b>	Flare Traversable RT?	No
			<b>N/A</b>	DWS Provided?	N/A
			<b>N/A</b>	DWS Contrast?	N/A
			<b>N/A</b>	DWS Length (in)	N/A
			<b>N/A</b>	DWS Full Width?	N/A
			<b>N/A</b>	DWS Offset (in)	N/A
			<b>N/A</b>	Gutter Ponding?	N/A
			<b>N/A</b>	Gutter Lip Ht (in)	N/A

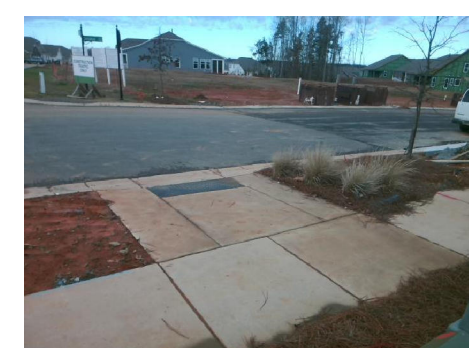
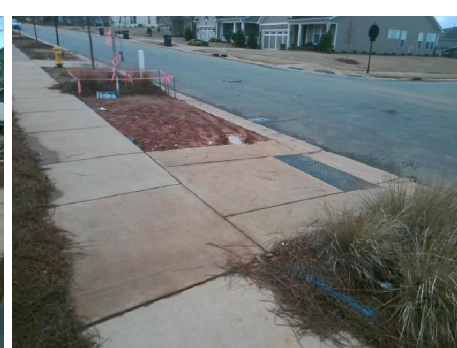
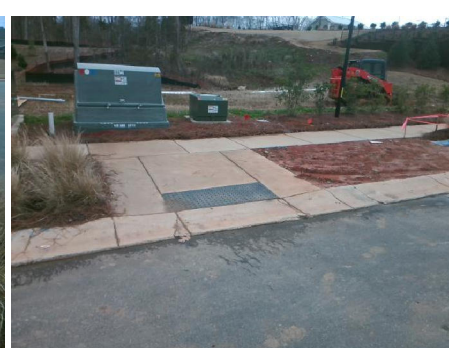
<b>No</b>	Painted X Walk1?	N/A
				X Walk 1 Direction	To E
			<b>N/A</b>	X Walk 1 Width (in)	N/A
				X Walk 1 Slope (%)	2.2
				X Walk 1 X Slope (%)	2.0
			<b>N/A</b>	Ramp inside XWalk1?	N/A
			<b>N/A</b>	Road Slope (%)	N/A
			<b>N/A</b>	Road X Slope (%)	N/A
			<b>N/A</b>	Any Obstructions?	N/A
				Obstruction Type	
Total Cost:		\$ 1850.00	<b>N/A</b>	Storm Grate/Utility Hazard?	N/A
			<b>N/A</b>	Storm Grate/Utility Type	N/A
			<b>Yes</b>	Surface Condition? (G/P)	Good
