# Access Compliance Report

## Public Rights-of-Way

### (Curb Ramps)

Intersection ID: 10899	Main Street: AUTEN_ST	Cross Street: DUCKWORTH_AV	Location: S
ADA ID: 9AFBED38252E	Ramp Type: PerpDiag	Initial Pass/Fail: Fail	Overall Compliance: No
Severity Score: 8.75			
Codes/Mitigation Info/Possible Solution		Field Measurements/Component Compliance

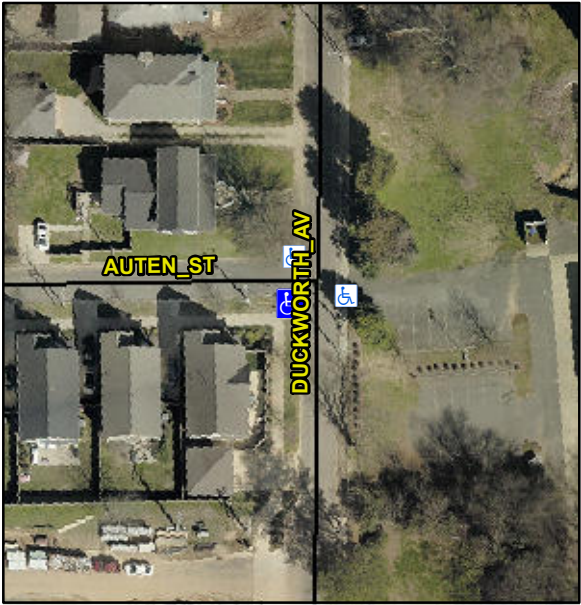
Possible Solutions:	Compliance	Description	Data	Compliance	Description	Data
	Remove & Replace Curb Ramp With Two New Directional Ramps or Equivalent.	N/A	Ramp Length (in)	121.0	Yes	Ramp Slope (%)	7.4
<p>Surveyor Notes:</p> <p>N/A</p> <p>PROW/ADA:</p> <p>Not Found, R304.5.1</p>		No	Ramp Width (in)	47.0	Yes	Ramp XSlope (%)	1.3
		N/A	Flare Type LT	N/A	N/A	Flare Type RT	N/A
		N/A	Flare Slope LT (%)	N/A	N/A	Flare Slope RT (%)	N/A
		N/A	Flare Traversable LT?	N/A	N/A	Flare Traversable RT?	N/A
		N/A	Landing Length (in)	N/A	N/A	DWS Provided?	N/A
		N/A	Landing Width (in)	N/A	N/A	DWS Contrast?	N/A
		N/A	Landing Slope (%)	N/A	N/A	DWS Length (in)	N/A
		N/A	Landing X Slope (%)	N/A	N/A	DWS Full Width?	N/A
		N/A	Landing Curb? (Y/N)	N/A	N/A	DWS Offset (in)	N/A
		N/A	Shared Landing?	N/A			
		N/A	Gutter Ponding?	N/A	N/A	Gutter Slope (%)	N/A
		N/A	Gutter Lip Ht (in)	N/A	N/A	Gutter X Slope (%)	N/A
		N/A	Painted X Walk1?	No	N/A	Painted X Walk2?	No

X Walk 1 Direction	To E		X Walk 2 Direction	To N
		N/A	X Walk 1 Width (in)	N/A	N/A	X Walk 2 Width (in)	N/A
			X Walk 1 Slope (%)	4.8		X Walk 2 Slope (%)	2.1
			X Walk 1 X Slope (%)	3.3		X Walk 2 X Slope (%)	0.3
		N/A	Ramp inside XWalk1?	N/A	N/A	Ramp inside XWalk2?	N/A
			Road Slope (%)	0.8	N/A	Clear Space?	N/A
			Road X Slope (%)	4.0	N/A	Clear Space to XWalk (in)	N/A
		N/A	Any Obstructions?	N/A	N/A	Storm Grate/Utility Hazard?	N/A
			Obstruction Type			Storm Grate/Utility Type	
					N/A		N/A
					Yes	Surface Condition? (G/P)	Good

Total Cost: \$ 3200.00
