Access Compliance Report

Public Rights-of-Way

(Curb Ramps)

Intersection ID: 4615	Main Street: CLAIREMORE_PL	Cross Street: TRINITY_RD	Location: SW
ADA ID: 9AFE0FCCB4B2	Ramp Type: Perp	Initial Pass/Fail: Fail	Overall Compliance: No
Severity Score: 22.5			
Codes/Mitigation Info/Possible Solution		Field Measurements/Component Compliance

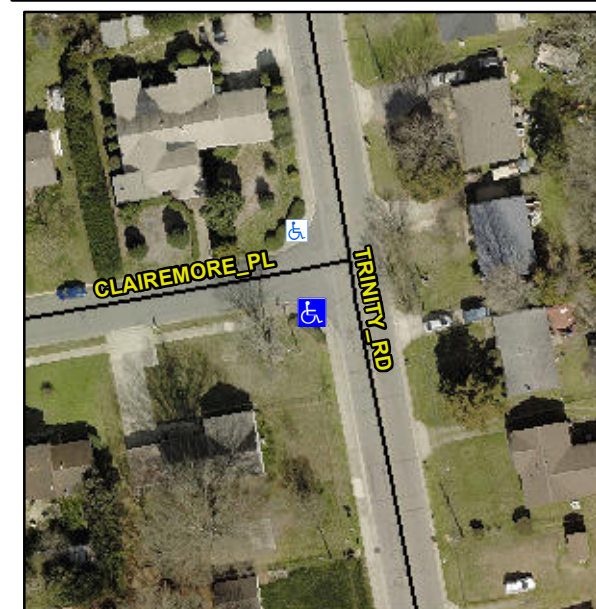
Compliance	Description	Data	Compliance	Description	Data
N/A	Ramp Length (in)	58.0	No	Ramp Slope (%)	11.4
No	Ramp Width (in)	39.0	No	Ramp XSlope (%)	2.4
N/A	Flare Type LT	N/A	N/A	Flare Type RT	N/A
N/A	Flare Slope LT (%)	N/A	N/A	Flare Slope RT (%)	N/A
N/A	Flare Traversable LT?	N/A	N/A	Flare Traversable RT?	N/A
N/A	Landing Length (in)	N/A	N/A	DWS Provided?	N/A
N/A	Landing Width (in)	N/A	N/A	DWS Contrast?	N/A
N/A	Landing Slope (%)	N/A	N/A	DWS Length (in)	N/A
N/A	Landing X Slope (%)	N/A	N/A	DWS Full Width?	N/A
N/A	Landing Curb? (Y/N)	N/A	N/A	DWS Offset (in)	N/A
N/A	Shared Landing?	N/A			
N/A	Gutter Ponding?	N/A	N/A	Gutter Slope (%)	N/A
N/A	Gutter Lip Ht (in)	1.0	N/A	Gutter X Slope (%)	N/A
N/A	Painted X Walk1?	No	N/A	Painted X Walk2?	N/A
	X Walk 1 Direction	To N		X Walk 2 Direction	N/A
N/A	X Walk 1 Width (in)	N/A	N/A	X Walk 2 Width (in)	N/A
	X Walk 1 Slope (%)	2.4		X Walk 2 Slope (%)	N/A
	X Walk 1 X Slope (%)	1.6		X Walk 2 X Slope (%)	N/A

N/A	Ramp inside XWalk1?	N/A	N/A	Ramp inside XWalk2?	N/A
	Road Slope (%)	N/A	N/A	Clear Space?	N/A
	Road X Slope (%)	N/A	N/A	Clear Space to XWalk (in)	N/A
N/A	Any Obstructions?	N/A	N/A	Storm Grate/Utility Hazard?	N/A
	Obstruction Type			Storm Grate/Utility Type	
		N/A			N/A
			Yes	Surface Condition? (G/P)	Good

Possible Solutions:

Remove & Replace Entire Ramp.
