# Access Compliance Report

## Public Rights-of-Way

| Intersection ID: 15034 | Main Street: OLMSTED_PARK_PL | Cross Street: SUMNER_GREEN_AV | Location: E |
| ADA ID: 9B099C1B61F3 | Ramp Type: Perp | Initial Pass/Fail: Fail | Overall Compliance: No |

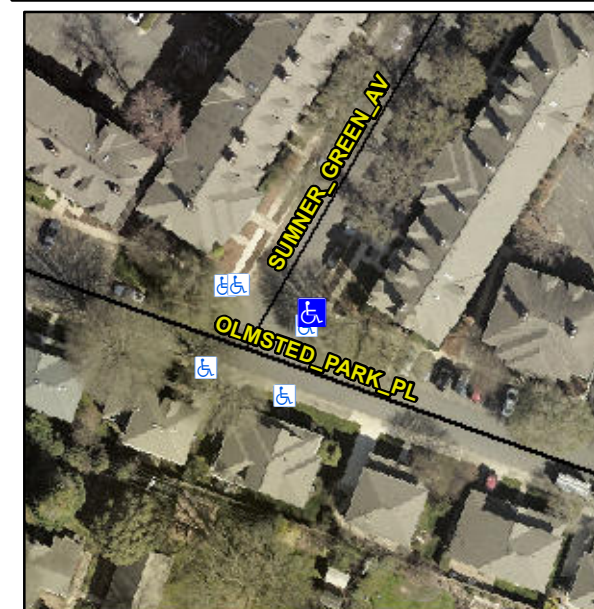
**Not Found, R304.5.3**

| Compliance | Description | Data | Compliance | Description | Data |
|---|---|---|---|---|---|
| Yes | Ramp Width (in) | 48.0 | No | Ramp XSlope (%) | 2.8 |

**Remove & Replace Entire Ramp.**

Total Cost: \$ 1850.00
