# Access Compliance Report

## Public Rights-of-Way

### (Curb Ramps)

Intersection ID: N/A	Main Street: E 8TH ST	Cross Street: N BREVARD ST	Location: E
ADA ID: 9B09AA4DFADA	Ramp Type: Perp	Initial Pass/Fail: Fail	Overall Compliance: No
Severity Score: 8.75			
Codes/Mitigation Info/Possible Solution		Field Measurements/Component Compliance

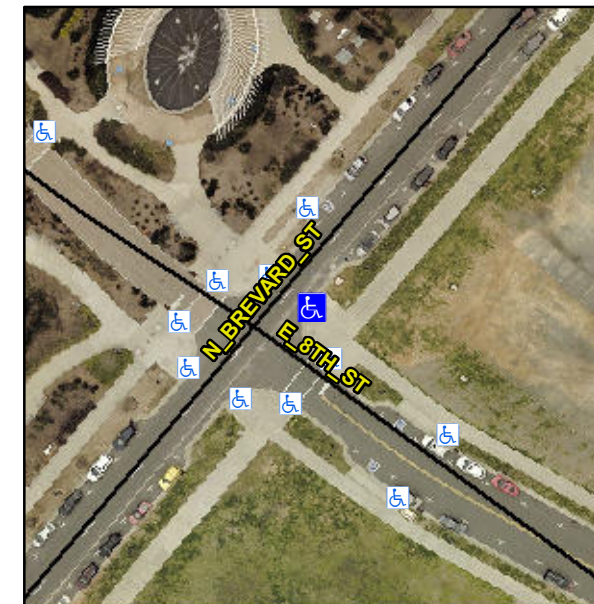
Compliance	Description	Data	Compliance	Description	Data
N/A	Ramp Length (in)	77.0	Yes	Ramp Slope (%)	5.3
No	Ramp Width (in)	45.0	Yes	Ramp XSlope (%)	0.6
N/A	Flare Type LT	N/A	N/A	Flare Type RT	N/A
N/A	Flare Slope LT (%)	N/A	N/A	Flare Slope RT (%)	N/A
N/A	Flare Traversable LT?	No	N/A	Flare Traversable RT?	No
N/A	Landing Length (in)	N/A	N/A	DWS Provided?	N/A
N/A	Landing Width (in)	N/A	N/A	DWS Contrast?	N/A
N/A	Landing Slope (%)	N/A	N/A	DWS Length (in)	N/A
N/A	Landing X Slope (%)	N/A	N/A	DWS Full Width?	N/A
N/A	Landing Curb? (Y/N)	N/A	N/A	DWS Offset (in)	N/A
N/A	Shared Landing?	N/A			
N/A	Gutter Ponding?	N/A	N/A	Gutter Slope (%)	N/A
N/A	Gutter Lip Ht (in)	N/A	N/A	Gutter X Slope (%)	N/A
N/A	Painted X Walk1?	No	N/A	Painted X Walk2?	N/A
	X Walk 1 Direction	To NW		X Walk 2 Direction	N/A
N/A	X Walk 1 Width (in)	N/A	N/A	X Walk 2 Width (in)	N/A
	X Walk 1 Slope (%)	2.1		X Walk 2 Slope (%)	N/A
	X Walk 1 X Slope (%)	1.1		X Walk 2 X Slope (%)	N/A

N/A	Ramp inside XWalk1?	N/A	N/A	Ramp inside XWalk2?	N/A
	Road Slope (%)	N/A	N/A	Clear Space?	N/A
	Road X Slope (%)	N/A	N/A	Clear Space to XWalk (in)	N/A
N/A	Any Obstructions?	N/A	N/A	Storm Grate/Utility Hazard?	N/A
	Obstruction Type			Storm Grate/Utility Type	
		N/A			N/A
		Yes		Surface Condition? (G/P)	Good

Possible Solutions:

**Remove & Replace Entire Ramp.**

PROW/ADA:

**R304.5.1**
