# Access Compliance Report

## Public Rights-of-Way

### (Curb Ramps)

Intersection ID: N/A	Main Street: RAKU_CT	Cross Street: N/A	Location: NW
ADA ID: 9B0B7875357C	Ramp Type: Perp	Initial Pass/Fail: Fail	Overall Compliance: No
		Severity Score: 25

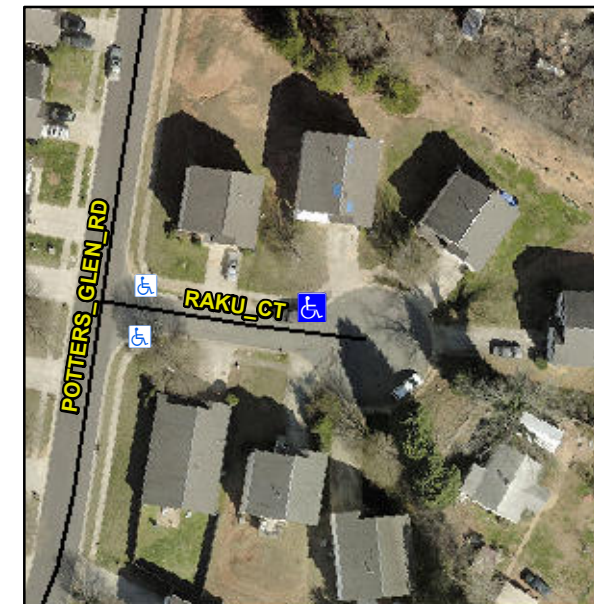
Compliance	Description	Data	Compliance	Description	Data
N/A	Ramp Length (in)	48.0	Yes	Ramp Slope (%)	7.7
Yes	Ramp Width (in)	48.0	No	Ramp XSlope (%)	7.1
N/A	Flare Type LT	N/A	N/A	Flare Type RT	N/A
N/A	Flare Slope LT (%)	N/A	N/A	Flare Slope RT (%)	N/A
N/A	Flare Traversable LT?	N/A	N/A	Flare Traversable RT?	N/A
N/A	Landing Length (in)	N/A	N/A	DWS Provided?	N/A
N/A	Landing Width (in)	N/A	N/A	DWS Contrast?	N/A
N/A	Landing Slope (%)	N/A	N/A	DWS Length (in)	N/A
N/A	Landing X Slope (%)	N/A	N/A	DWS Full Width?	N/A
N/A	Landing Curb? (Y/N)	N/A	N/A	DWS Offset (in)	N/A
N/A	Shared Landing?	N/A			
N/A	Gutter Ponding?	N/A	N/A	Gutter Slope (%)	N/A
N/A	Gutter Lip Ht (in)	N/A	N/A	Gutter X Slope (%)	N/A
N/A	Painted X Walk1?	No	N/A	Painted X Walk2?	N/A
	X Walk 1 Direction	To S		X Walk 2 Direction	N/A
N/A	X Walk 1 Width (in)	N/A	N/A	X Walk 2 Width (in)	N/A
	X Walk 1 Slope (%)	5.0		X Walk 2 Slope (%)	N/A
	X Walk 1 X Slope (%)	8.1		X Walk 2 X Slope (%)	N/A

N/A	Ramp inside XWalk1?	N/A	N/A	Ramp inside XWalk2?	N/A
	Road Slope (%)	N/A	N/A	Clear Space?	N/A
	Road X Slope (%)	N/A	N/A	Clear Space to XWalk (in)	N/A
N/A	Any Obstructions?	N/A	N/A	Storm Grate/Utility Hazard?	N/A
	Obstruction Type			Storm Grate/Utility Type	
		N/A			N/A
			Yes	Surface Condition? (G/P)	Good

**Remove & Replace Entire Ramp.**

**R304.5.3**
