Access Compliance Report

Public Rights-of-Way

(Curb Ramps)

Intersection ID: 19137	Main Street: CLIFTON_MEADOW_DR	Cross Street: OLD_GATE_DR	Location: NW
ADA ID: 9B165FEE65EB	Ramp Type: PerpDiag	Initial Pass/Fail: Fail	Overall Compliance: No
Severity Score: 46.25			
Codes/Mitigation Info/Possible Solution		Field Measurements/Component Compliance

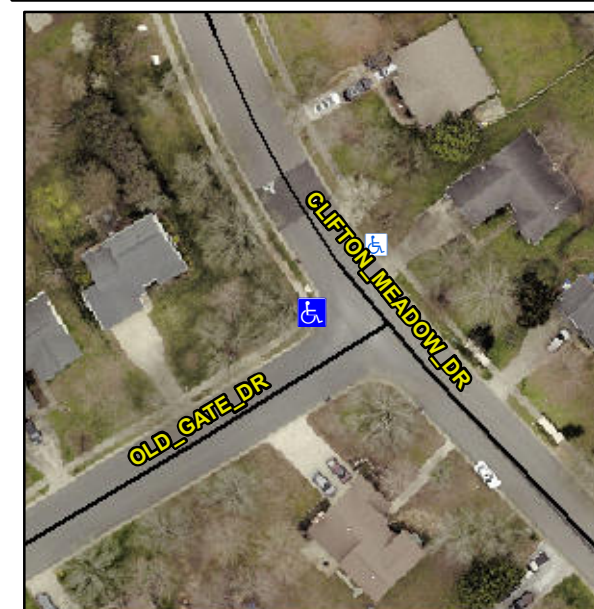
Not Found, R304.5.1, R304.2.2, R304.5.3

Compliance	Description	Data	Compliance	Description	Data
N/A	Ramp Length (in)	46.5	No	Ramp Slope (%)	8.6
No	Ramp Width (in)	47.0	No	Ramp XSlope (%)	7.2
N/A	Flare Type LT	N/A	N/A	Flare Type RT	N/A
N/A	Flare Slope LT (%)	N/A	N/A	Flare Slope RT (%)	N/A
N/A	Flare Traversable LT?	N/A	N/A	Flare Traversable RT?	N/A
N/A	Landing Length (in)	N/A	N/A	DWS Provided?	N/A
N/A	Landing Width (in)	N/A	N/A	DWS Contrast?	N/A
N/A	Landing Slope (%)	N/A	N/A	DWS Length (in)	N/A
N/A	Landing X Slope (%)	N/A	N/A	DWS Full Width?	N/A
N/A	Landing Curb? (Y/N)	N/A	N/A	DWS Offset (in)	N/A
N/A	Shared Landing?	N/A			
N/A	Gutter Ponding?	N/A	N/A	Gutter Slope (%)	N/A
N/A	Gutter Lip Ht (in)	N/A	N/A	Gutter X Slope (%)	N/A
N/A	Painted X Walk1?	No	N/A	Painted X Walk2?	No
	X Walk 1 Direction	To SE		X Walk 2 Direction	To NE
N/A	X Walk 1 Width (in)	N/A	N/A	X Walk 2 Width (in)	N/A
	X Walk 1 Slope (%)	2.9		X Walk 2 Slope (%)	0.1
	X Walk 1 X Slope (%)	3.2		X Walk 2 X Slope (%)	2.8

N/A	Ramp inside XWalk1?	N/A	N/A	Ramp inside XWalk2?	N/A
	Road Slope (%)	4.2	N/A	Clear Space?	N/A
	Road X Slope (%)	0.7	N/A	Clear Space to XWalk (in)	N/A
N/A	Any Obstructions?	N/A	N/A	Storm Grate/Utility Hazard?	N/A
	Obstruction Type			Storm Grate/Utility Type	
		N/A			N/A
			Yes	Surface Condition? (G/P)	Good

Possible Solutions:

Remove & Replace Curb Ramp With Two New Directional Ramps or Equivalent.
