# Access Compliance Report

## Public Rights-of-Way

### (Curb Ramps)

Intersection ID: 31481	Main Street: FLAGLER_LN	Cross Street: ROLETTE_CT	Location: SW
ADA ID: 9B191FD232D3	Ramp Type: PerpDiag	Initial Pass/Fail: Fail	Overall Compliance: No
Severity Score: 33.75			
Codes/Mitigation Info/Possible Solution		Field Measurements/Component Compliance

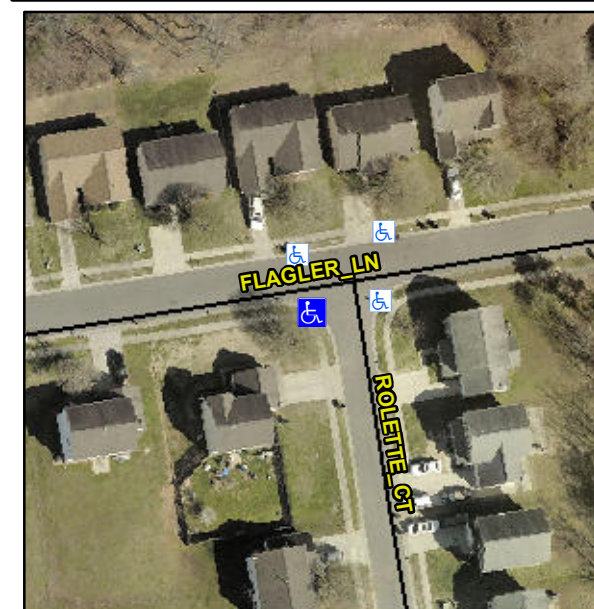
**Not Found, R304.5.1, R304.5.3**

Compliance	Description	Data	Compliance	Description	Data
N/A	Ramp Length (in)	47.5	Yes	Ramp Slope (%)	5.0
No	Ramp Width (in)	47.5	No	Ramp XSlope (%)	8.3
N/A	Flare Type LT	N/A	N/A	Flare Type RT	N/A
N/A	Flare Slope LT (%)	N/A	N/A	Flare Slope RT (%)	N/A
N/A	Flare Traversable LT?	N/A	N/A	Flare Traversable RT?	N/A
N/A	Landing Length (in)	N/A	N/A	DWS Provided?	N/A
N/A	Landing Width (in)	N/A	N/A	DWS Contrast?	N/A
N/A	Landing Slope (%)	N/A	N/A	DWS Length (in)	N/A
N/A	Landing X Slope (%)	N/A	N/A	DWS Full Width?	N/A
N/A	Landing Curb? (Y/N)	N/A	N/A	DWS Offset (in)	N/A
N/A	Shared Landing?	N/A			
N/A	Gutter Ponding?	N/A	N/A	Gutter Slope (%)	N/A
N/A	Gutter Lip Ht (in)	N/A	N/A	Gutter X Slope (%)	N/A
N/A	Painted X Walk1?	No	N/A	Painted X Walk2?	No
	X Walk 1 Direction	To E		X Walk 2 Direction	To N
N/A	X Walk 1 Width (in)	N/A	N/A	X Walk 2 Width (in)	N/A
	X Walk 1 Slope (%)	3.8		X Walk 2 Slope (%)	6.6
	X Walk 1 X Slope (%)	5.3		X Walk 2 X Slope (%)	5.5

N/A	Ramp inside XWalk1?	N/A	N/A	Ramp inside XWalk2?	N/A
	Road Slope (%)	7.8	N/A	Clear Space?	N/A
	Road X Slope (%)	0.9	N/A	Clear Space to XWalk (in)	N/A
N/A	Any Obstructions?	N/A	N/A	Storm Grate/Utility Hazard?	N/A
	Obstruction Type			Storm Grate/Utility Type	
		N/A			N/A
		Yes		Surface Condition? (G/P)	Good

**Remove & Replace Curb Ramp With Two New Directional Ramps or Equivalent.**
