Access Compliance Report

Public Rights-of-Way

(Curb Ramps)

Intersection ID: 10798	Main Street: W_5TH_ST	Cross Street: N_BRUNS_AV	Location: S
ADA ID: 9B234ECA8F12	Ramp Type: ParaDiag	Initial Pass/Fail: Fail	Overall Compliance: No
			Severity Score: 26.25

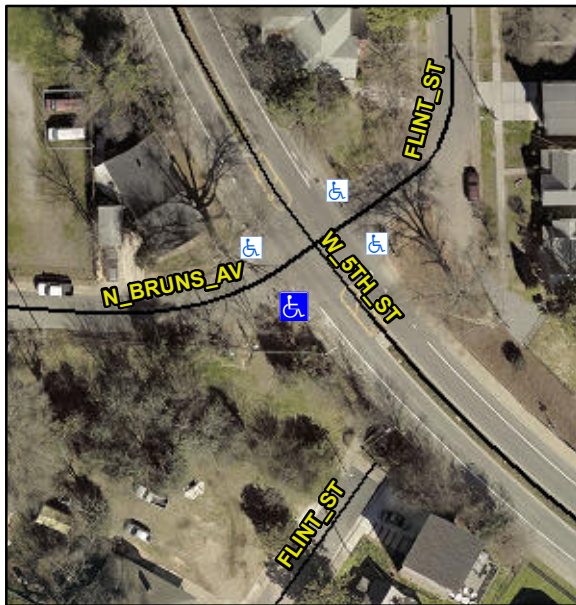
LT RP < 5%

R304.5.3, R304.3.2

Compliance	Description	Data	Compliance	Description	Data
N/A	Ramp Length LT (in)	45.0	N/A	Ramp Length RT (in)	62.0
Yes	Ramp Width LT (in)	48.0	Yes	Ramp Width RT (in)	48.0
Yes	Ramp Slope LT (%)	4.7	No	Ramp Slope RT (%)	14.0
No	Ramp XSlope LT (%)	2.8	No	Ramp XSlope RT (%)	2.7
N/A	Landing Length (in)	N/A	N/A	DWS Provided?	N/A
N/A	Landing Width (in)	N/A	N/A	DWS Contrast?	N/A
N/A	Landing Slope (%)	N/A	N/A	DWS Length (in)	N/A
N/A	Landing X Slope (%)	N/A	N/A	DWS Full Width?	N/A
N/A	Landing Curb? (Y/N)	N/A	N/A	DWS Offset (in)	N/A
N/A	Shared Landing?	N/A			
N/A	Gutter Ponding?	N/A	N/A	Gutter Slope (%)	N/A
N/A	Gutter Lip Ht (in)	N/A	N/A	Gutter X Slope (%)	N/A
N/A	Painted X Walk1?	No	N/A	Painted X Walk2?	No
	X Walk 1 Direction	To NE		X Walk 2 Direction	To NW
N/A	X Walk 1 Width (in)	N/A	N/A	X Walk 2 Width (in)	N/A
	X Walk 1 Slope (%)	1.7		X Walk 2 Slope (%)	7.6
	X Walk 1 X Slope (%)	5.8		X Walk 2 X Slope (%)	3.6
N/A	Ramp inside XWalk1?	N/A	N/A	Ramp inside XWalk2?	N/A

Road Slope (%)	5.6	N/A	Clear Space?	N/A
	Road X Slope (%)	4.4	N/A	Clear Space to XWalk (in)	N/A
N/A	Any Obstructions?	N/A	N/A	Storm Grate/Utility Hazard?	N/A
	Obstruction Type			Storm Grate/Utility Type	
		N/A			N/A
			Yes	Surface Condition? (G/P)	Good
			N/A	Curb Slope (%)	18.8

Remove & Replace Curb Ramp With Two New Directional Ramps or Equivalent.
