Access Compliance Report

Public Rights-of-Way

(Curb Ramps)

Intersection ID: 10569	Main Street: PLYMOUTH_AV	Cross Street: BANCROFT_ST	Location: S
ADA ID: 9B5E405B5EB0	Ramp Type: Perp	Initial Pass/Fail: Fail	Overall Compliance: No
		Severity Score: 10

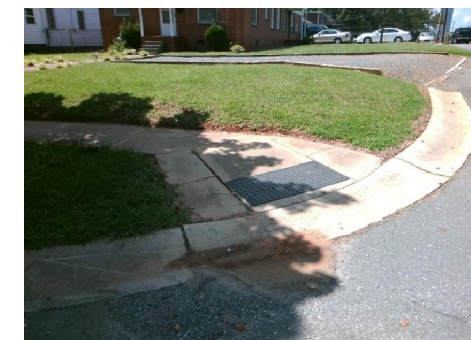
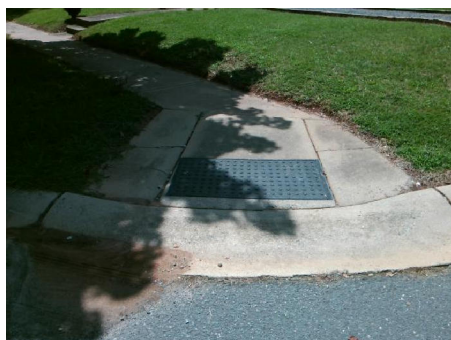
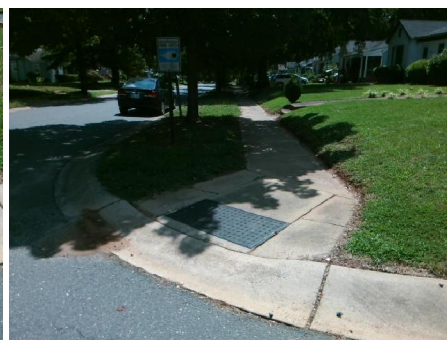
Not Found, R304.5.1, R304.5.3

Compliance	Description	Data	Compliance	Description	Data
N/A	Ramp Length (in)	65.5	Yes	Ramp Slope (%)	5.6
No	Ramp Width (in)	45.0	No	Ramp XSlope (%)	4.1
N/A	Flare Type LT	N/A	N/A	Flare Type RT	N/A
N/A	Flare Slope LT (%)	N/A	N/A	Flare Slope RT (%)	N/A
N/A	Flare Traversable LT?	N/A	N/A	Flare Traversable RT?	N/A
N/A	Landing Length (in)	N/A	N/A	DWS Provided?	N/A
N/A	Landing Width (in)	N/A	N/A	DWS Contrast?	N/A
N/A	Landing Slope (%)	N/A	N/A	DWS Length (in)	N/A
N/A	Landing X Slope (%)	N/A	N/A	DWS Full Width?	N/A
N/A	Landing Curb? (Y/N)	N/A	N/A	DWS Offset (in)	N/A
N/A	Shared Landing?	N/A			
N/A	Gutter Ponding?	Yes	N/A	Gutter Slope (%)	N/A
N/A	Gutter Lip Ht (in)	N/A	N/A	Gutter X Slope (%)	N/A
N/A	Painted X Walk1?	No	N/A	Painted X Walk2?	N/A
	X Walk 1 Direction	To NW		X Walk 2 Direction	N/A
N/A	X Walk 1 Width (in)	N/A	N/A	X Walk 2 Width (in)	N/A
	X Walk 1 Slope (%)	0.5		X Walk 2 Slope (%)	N/A
	X Walk 1 X Slope (%)	4.8		X Walk 2 X Slope (%)	N/A

Remove & Replace Entire Ramp.
