## **Access Compliance Report Public Rights-of-Way** (Curb Ramps)

Intersection ID: 8626 Main Street: N\_TRYON\_ST Cross Street: NORTHCHASE\_DR Location: **Overall Compliance: No** Severity Score: 13.75 ADA ID: 9B60DC801D60 Ramp Type: Perp Initial Pass/Fail: Fail

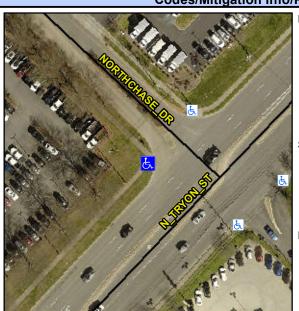
Field Measurements/Component Compliance								
Comp	liance Description	Data	Comp	liance Description	Data			
N/A	Ramp Length (in)	63.0	No	Ramp Slope (%)	8.6			
Yes	Ramp Width (in)	48.0	No	Ramp XSlope (%)	2.8			
N/A	Flare Type LT	N/A	N/A	Flare Type RT	N/A			
N/A	Flare Slope LT (%)	N/A	N/A	Flare Slope RT (%)	N/A			
N/A	Flare Traversable LT?	N/A	N/A	Flare Traversable RT?	N/A			
N/A	Landing Length (in)	N/A	N/A	DWS Provided?	N/A			
N/A	Landing Width (in)	N/A	N/A	DWS Contrast?	N/A			
N/A	Landing Slope (%)	N/A	N/A	DWS Length (in)	N/A			
N/A	Landing X Slope (%)	N/A	N/A	DWS Full Width?	N/A			
N/A	Landing Curb? (Y/N)	N/A	N/A	DWS Offset (in)	N/A			
N/A	Shared Landing?	N/A						
N/A	Gutter Ponding?	N/A	N/A	Gutter Slope (%)	N/A			
N/A	Gutter Lip Ht (in)	N/A	N/A	Gutter X Slope (%)	N/A			
N/A	Painted X Walk1?	No	N/A	Painted X Walk2?	N/A			
	X Walk 1 Direction	To NE		X Walk 2 Direction	N/A			
N/A	X Walk 1 Width (in)	N/A	N/A	X Walk 2 Width (in)	N/A

X Walk 1 Slope (%)	0.1		X Walk 2 Slope (%)	N/A			
	X Walk 1 X Slope (%)	1.3		X Walk 2 X Slope (%)	N/A			
N/A	Ramp inside XWalk1?	N/A	N/A	Ramp inside XWalk2?	N/A			
	Road Slope (%)	N/A	N/A	Clear Space?	N/A			
	Road X Slope (%)	N/A	N/A	Clear Space to XWalk (in)	N/A			
N/A	Any Obstructions?	N/A	N/A	Storm Grate/Utility Hazard?	N/A			
	Obstruction Type			Storm Grate/Utility Type				
		N/A			N/A			
			Yes	Surface Condition? (G/P)	Good			
A BA

Possible Solution
Possible Solutions:
Remove & Replace Entire Ramp.
Surveyor Notes:
N/A
DDOW/ADA.
PROW/ADA:
Not Found, R304.2.2, R304.5.3

,	
Total Cost:	\$	1850.00
