# Access Compliance Report

## Public Rights-of-Way

### (Curb Ramps)

Intersection ID: 6151	Main Street: COREOPSIS_RD	Cross Street: LIATRIS_LN	Location: SW
ADA ID: 9B6D2C8DF7AF	Ramp Type: Perp	Initial Pass/Fail: Fail	Overall Compliance: No Severity Score: 33.75

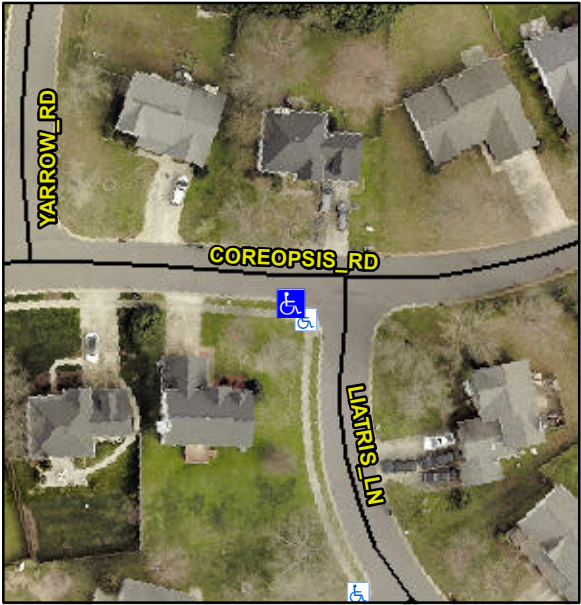
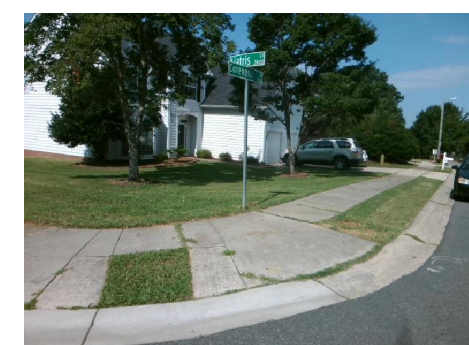
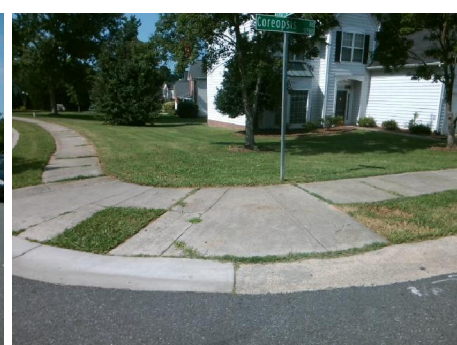
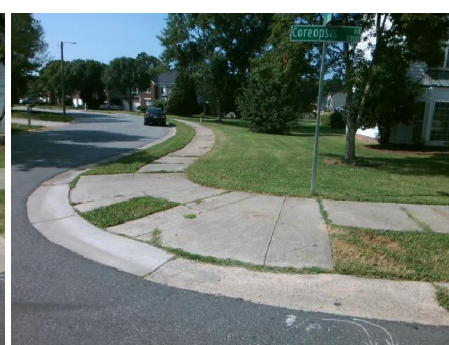
Possible Solutions:		<b>Compliance</b>	<b>Description</b>	<b>Data</b>
	<b>Remove &amp; Replace Entire Ramp.</b>		<b>No</b>	Ramp Length (in)	47.0
			<b>No</b>	Ramp Width (in)	46.0
			<b>N/A</b>	Flare Type LT	N/A
			<b>N/A</b>	Flare Slope LT (%)	N/A
			<b>N/A</b>	Flare Traversable LT?	N/A
			<b>N/A</b>	Landing Length (in)	N/A
			<b>N/A</b>	Landing Width (in)	N/A
			<b>N/A</b>	Landing Slope (%)	N/A
			<b>N/A</b>	Landing X Slope (%)	N/A
<p>Surveyor Notes:</p> <p><b>N/A</b></p> <p>PROW/ADA:</p> <p><b>Not Found, R304.5.1, R304.2.2, R304.5.3</b></p>			<b>N/A</b>	Flare Type RT	N/A
			<b>N/A</b>	Flare Slope RT (%)	N/A
			<b>N/A</b>	Flare Traversable RT?	N/A
			<b>N/A</b>	DWS Provided?	N/A
			<b>N/A</b>	DWS Contrast?	N/A
			<b>N/A</b>	DWS Length (in)	N/A
			<b>N/A</b>	DWS Full Width?	N/A
			<b>N/A</b>	DWS Offset (in)	N/A
			<b>N/A</b>	Shared Landing?	N/A

<b>N/A</b>	Gutter Ponding?	N/A
			<b>N/A</b>	Gutter Lip Ht (in)	N/A
			<b>N/A</b>	Painted X Walk1?	No
				X Walk 1 Direction	To N
			<b>N/A</b>	X Walk 1 Width (in)	N/A
				X Walk 1 Slope (%)	4.2
				X Walk 1 X Slope (%)	3.2
			<b>N/A</b>	Ramp inside XWalk1?	N/A
			<b>N/A</b>	Road Slope (%)	N/A
			<b>N/A</b>	Road X Slope (%)	N/A
			<b>N/A</b>	Any Obstructions?	N/A
				Obstruction Type	
			<b>N/A</b>		
			<b>N/A</b>		
			<b>N/A</b>		
			<b>N/A</b>		
			<b>N/A</b>		
			<b>N/A</b>		
			<b>N/A</b>		
			<b>N/A</b>		
			<b>N/A</b>		
Total Cost:		\$ 1850.00			
Street 1 Name	COREOPSIS RD				
Stop Condition-Street 2	None				
Street 2 Name	N/A				
Stop Condition-Street 1	N/A				
			<b>N/A</b>	Clear Space?	N/A
			<b>N/A</b>	Clear Space to XWalk (in)	N/A
			<b>N/A</b>	Storm Grate/Utility Hazard?	N/A
				Storm Grate/Utility Type	
			<b>N/A</b>		N/A
			<b>Yes</b>	Surface Condition? (G/P)	Good
