Access Compliance Report

Public Rights-of-Way

(Curb Ramps)

Intersection ID: 31722	Main Street: FILBERT_LN	Cross Street: WEEING FIG_LN	Location: NW
ADA ID: 9B73B2D6FF78	Ramp Type: PerpDiag	Initial Pass/Fail: Fail	Overall Compliance: No
		Severity Score: 8.75

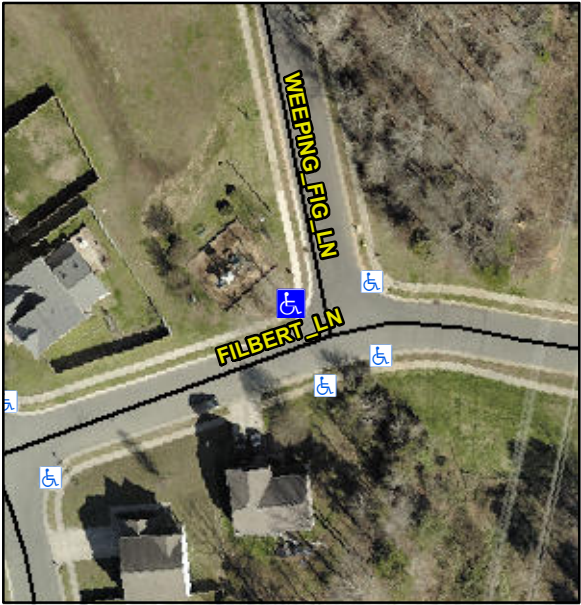
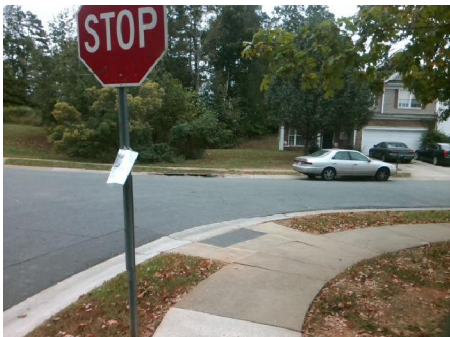
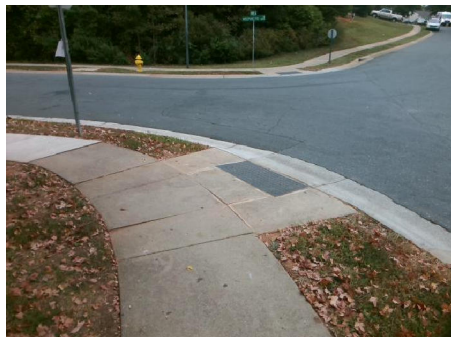
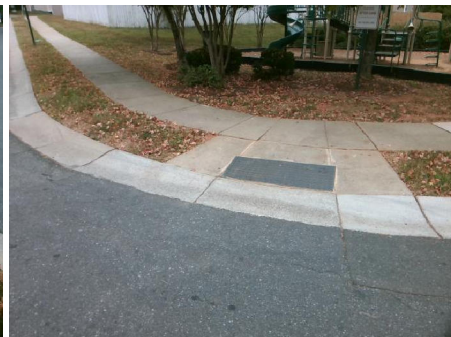
Compliance	Description	Data	Compliance	Description	Data
N/A	Ramp Length (in)	46.0	Yes	Ramp Slope (%)	7.1
No	Ramp Width (in)	39.0	Yes	Ramp XSlope (%)	1.1
N/A	Flare Type LT	N/A	N/A	Flare Type RT	N/A
N/A	Flare Slope LT (%)	N/A	N/A	Flare Slope RT (%)	N/A
N/A	Flare Traversable LT?	N/A	N/A	Flare Traversable RT?	N/A
N/A	Landing Length (in)	N/A	N/A	DWS Provided?	N/A
N/A	Landing Width (in)	N/A	N/A	DWS Contrast?	N/A
N/A	Landing Slope (%)	N/A	N/A	DWS Length (in)	N/A
N/A	Landing X Slope (%)	N/A	N/A	DWS Full Width?	N/A
N/A	Landing Curb? (Y/N)	N/A	N/A	DWS Offset (in)	N/A
N/A	Shared Landing?	N/A			
N/A	Gutter Ponding?	N/A	N/A	Gutter Slope (%)	N/A
N/A	Gutter Lip Ht (in)	N/A	N/A	Gutter X Slope (%)	N/A
N/A	Painted X Walk1?	No	N/A	Painted X Walk2?	No
	X Walk 1 Direction	To S		X Walk 2 Direction	To E
N/A	X Walk 1 Width (in)	N/A	N/A	X Walk 2 Width (in)	N/A
	X Walk 1 Slope (%)	3.6		X Walk 2 Slope (%)	2.5
	X Walk 1 X Slope (%)	2.1		X Walk 2 X Slope (%)	4.6

N/A	Ramp inside XWalk1?	N/A	N/A	Ramp inside XWalk2?	N/A
	Road Slope (%)	1.0	N/A	Clear Space?	N/A
	Road X Slope (%)	4.4	N/A	Clear Space to XWalk (in)	N/A
N/A	Any Obstructions?	N/A	N/A	Storm Grate/Utility Hazard?	N/A
	Obstruction Type			Storm Grate/Utility Type	
		N/A			N/A
			Yes	Surface Condition? (G/P)	Good

Possible Solutions:				
	Remove & Replace Curb Ramp With Two New Directional Ramps or Equivalent.				
	Surveyor Notes:				
	N/A				
	PROW/ADA:				
	Not Found, R304.5.1				
Street 1 Name	FILBERT LN				
Stop Condition-Street 2	None				
Street 2 Name	WEEING FIG LN				
Stop Condition-Street 1	StopSign				
Total Cost:		\$	3200.00
