# Access Compliance Report

## Public Rights-of-Way

### (Curb Ramps)

Intersection ID: 31771	Main Street: STARNES RANDALL RD	Cross Street: PINYON PINE LN	Location: S
ADA ID: 9B7A783D6A68	Ramp Type: Perp	Initial Pass/Fail: Fail	Overall Compliance: No
Severity Score: 12.5			
Codes/Mitigation Info/Possible Solution		Field Measurements/Component Compliance

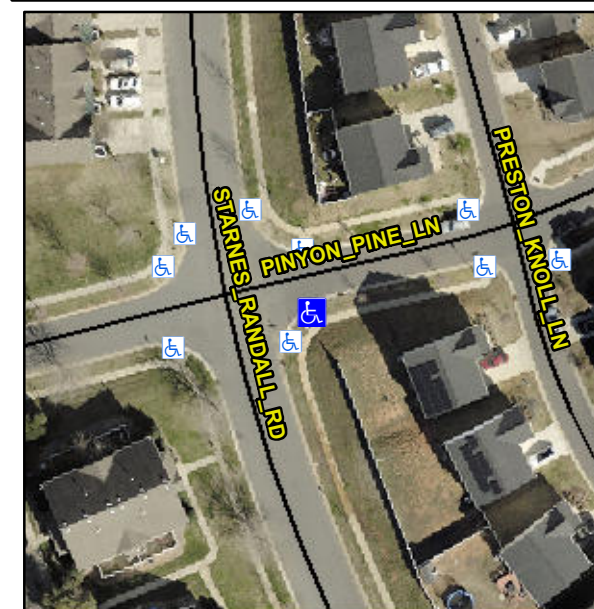
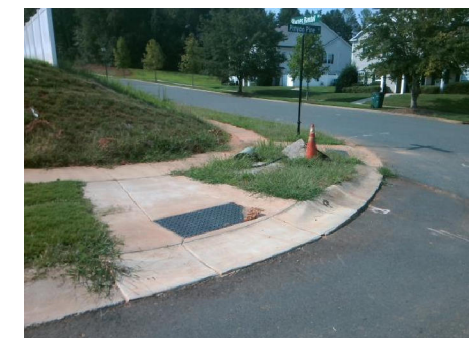
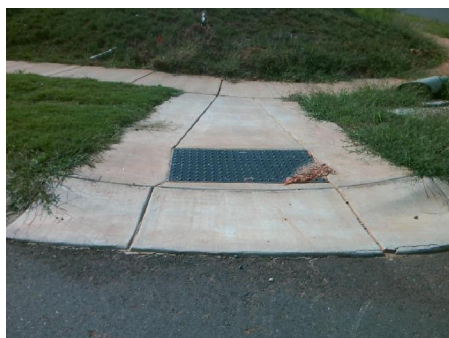
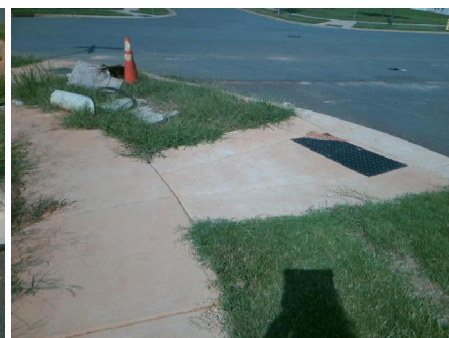
**Not Found, R304.5.3**

Compliance	Description	Data	Compliance	Description	Data
N/A	Ramp Length (in)	96.0	Yes	Ramp Slope (%)	5.5
Yes	Ramp Width (in)	160.0	No	Ramp XSlope (%)	6.4
N/A	Flare Type LT	N/A	N/A	Flare Type RT	N/A
N/A	Flare Slope LT (%)	N/A	N/A	Flare Slope RT (%)	N/A
N/A	Flare Traversable LT?	N/A	N/A	Flare Traversable RT?	N/A
N/A	Landing Length (in)	N/A	N/A	DWS Provided?	N/A
N/A	Landing Width (in)	N/A	N/A	DWS Contrast?	N/A
N/A	Landing Slope (%)	N/A	N/A	DWS Length (in)	N/A
N/A	Landing X Slope (%)	N/A	N/A	DWS Full Width?	N/A
N/A	Landing Curb? (Y/N)	N/A	N/A	DWS Offset (in)	N/A
N/A	Shared Landing?	N/A			
N/A	Gutter Ponding?	N/A	N/A	Gutter Slope (%)	N/A
N/A	Gutter Lip Ht (in)	N/A	N/A	Gutter X Slope (%)	N/A
N/A	Painted X Walk1?	No	N/A	Painted X Walk2?	N/A
	X Walk 1 Direction	To N		X Walk 2 Direction	N/A
N/A	X Walk 1 Width (in)	N/A	N/A	X Walk 2 Width (in)	N/A
	X Walk 1 Slope (%)	2.6		X Walk 2 Slope (%)	N/A
	X Walk 1 X Slope (%)	6.5		X Walk 2 X Slope (%)	N/A

N/A	Ramp inside XWalk1?	N/A	N/A	Ramp inside XWalk2?	N/A
	Road Slope (%)	N/A	N/A	Clear Space?	N/A
	Road X Slope (%)	N/A	N/A	Clear Space to XWalk (in)	N/A
N/A	Any Obstructions?	N/A	N/A	Storm Grate/Utility Hazard?	N/A
	Obstruction Type			Storm Grate/Utility Type	
		N/A			N/A
		Yes		Surface Condition? (G/P)	Good

**Remove & Replace Entire Ramp.**
