Access Compliance Report

Public Rights-of-Way

(Curb Ramps)

| Intersection ID: N/A | Main Street: LANGWELL_LN | Cross Street: INVERNESS_BAY_RD | Location: SE |

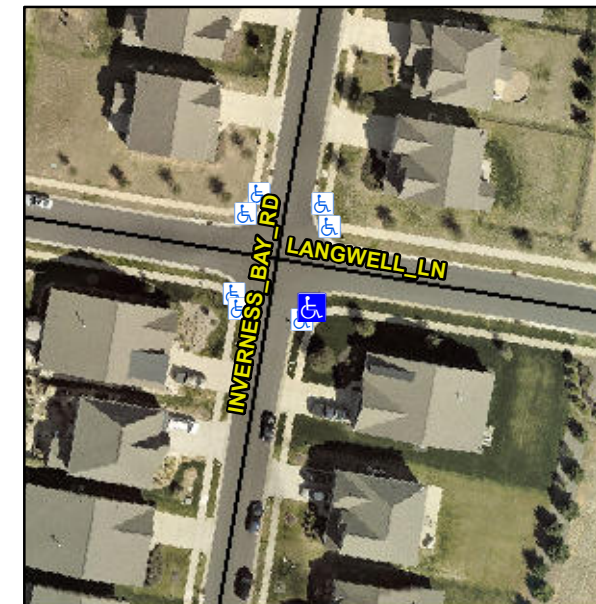
| ADA ID: 9B7BB62D03A9 | Ramp Type: Perp | Initial Pass/Fail: Fail | Overall Compliance: No |
| | | Severity Score: 8.75 | |

R304.5.1

| Compliance | Description | Data | Compliance | Description | Data |
|---|---|---|---|---|---|
| No | Ramp Width (in) | 45.5 | Yes | Ramp XSlope (%) | 1.4 |

Possible Solutions:

Remove & Replace Entire Ramp.

Total Cost: \$ 1850.00
