Access Compliance Report

Public Rights-of-Way

(Curb Ramps)

Intersection ID: 42367	Main Street: FALCONCREST_DR	Cross Street: KESTRAL_RIDGE_DR	Location: W
ADA ID: 9B83D91EF585	Ramp Type: PerpDiag	Initial Pass/Fail: Fail	Overall Compliance: No
Severity Score: 12.5			
Codes/Mitigation Info/Possible Solution		Field Measurements/Component Compliance

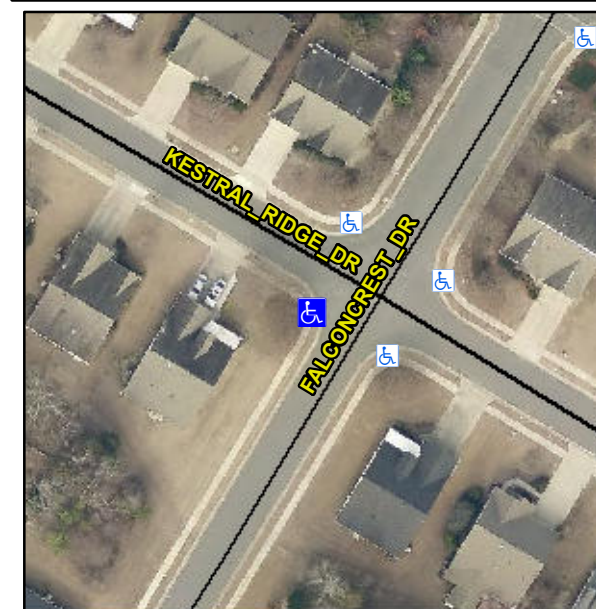
Compliance	Description	Data	Compliance	Description	Data
N/A	Ramp Length (in)	45.0	No	Ramp Slope (%)	8.6
Yes	Ramp Width (in)	51.0	Yes	Ramp XSlope (%)	0.0
N/A	Flare Type LT	N/A	N/A	Flare Type RT	N/A
N/A	Flare Slope LT (%)	N/A	N/A	Flare Slope RT (%)	N/A
N/A	Flare Traversable LT?	N/A	N/A	Flare Traversable RT?	N/A
N/A	Landing Length (in)	N/A	N/A	DWS Provided?	N/A
N/A	Landing Width (in)	N/A	N/A	DWS Contrast?	N/A
N/A	Landing Slope (%)	N/A	N/A	DWS Length (in)	N/A
N/A	Landing X Slope (%)	N/A	N/A	DWS Full Width?	N/A
N/A	Landing Curb? (Y/N)	N/A	N/A	DWS Offset (in)	N/A
N/A	Shared Landing?	N/A			
N/A	Gutter Ponding?	N/A	N/A	Gutter Slope (%)	N/A
N/A	Gutter Lip Ht (in)	N/A	N/A	Gutter X Slope (%)	N/A
N/A	Painted X Walk1?	No	N/A	Painted X Walk2?	No
	X Walk 1 Direction	To SE		X Walk 2 Direction	To NE
N/A	X Walk 1 Width (in)	N/A	N/A	X Walk 2 Width (in)	N/A
	X Walk 1 Slope (%)	0.7		X Walk 2 Slope (%)	2.4
	X Walk 1 X Slope (%)	0.4		X Walk 2 X Slope (%)	3.6

N/A	Ramp inside XWalk1?	N/A	N/A	Ramp inside XWalk2?	N/A
	Road Slope (%)	1.0	N/A	Clear Space?	N/A
	Road X Slope (%)	2.2	N/A	Clear Space to XWalk (in)	N/A
N/A	Any Obstructions?	N/A	N/A	Storm Grate/Utility Hazard?	N/A
	Obstruction Type			Storm Grate/Utility Type	
		N/A			N/A
			Yes	Surface Condition? (G/P)	Good

Remove & Replace Curb Ramp With Two New Directional Ramps or Equivalent.
