Access Compliance Report

Public Rights-of-Way

(Curb Ramps)

Intersection ID: 29145	Main Street: CRAWFORD_BROOK_LN	Cross Street: DEATON_HILL_DR	Location: SW
ADA ID: 9B841A7B433E	Ramp Type: BlendTrans1	Initial Pass/Fail: Fail	Overall Compliance: No
Severity Score: 10			
Codes/Mitigation Info/Possible Solution		Field Measurements/Component Compliance

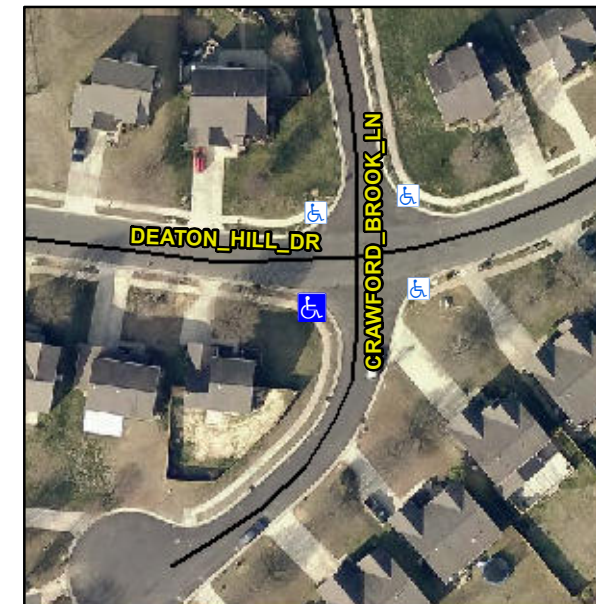
Not Found, R304.5.1, R304.5.3

Compliance	Description	Data	Compliance	Description	Data
N/A	Ramp Length (in)	48.0	Yes	BlendTrans Slope (%)	4.8
No	Ramp Width (in)	47.5	No	BlendTrans XSlope (%)	3.2
N/A	Flare Type LT	N/A	N/A	Flare Type RT	N/A
N/A	Flare Slope LT (%)	N/A	N/A	Flare Slope RT (%)	N/A
N/A	Flare Traversable LT?	N/A	N/A	Flare Traversable RT?	N/A
N/A	Landing Length (in)	N/A	N/A	DWS Provided?	N/A
N/A	Landing Width (in)	N/A	N/A	DWS Contrast?	N/A
N/A	Landing Slope (%)	N/A	N/A	DWS Length (in)	N/A
N/A	Landing X Slope (%)	N/A	N/A	DWS Full Width?	N/A
N/A	Landing Curb? (Y/N)	N/A	N/A	DWS Offset (in)	N/A
N/A	Shared Landing?	N/A			
N/A	Gutter Ponding?	N/A	N/A	Gutter Slope (%)	N/A
N/A	Gutter Lip Ht (in)	N/A	N/A	Gutter X Slope (%)	N/A
N/A	Painted X Walk1?	No	N/A	Painted X Walk2?	No
	X Walk 1 Direction	To E		X Walk 2 Direction	To N
	X Walk 1 Width (in)	N/A		X Walk 2 Width (in)	N/A
	X Walk 1 Slope (%)	1.5		X Walk 2 Slope (%)	0.0
	X Walk 1 X Slope (%)	1.6		X Walk 2 X Slope (%)	0.9

N/A	Ramp inside XWalk1?	N/A	N/A	Ramp inside XWalk2?	N/A
	Road Slope (%)	3.5		Clear Space?	N/A
	Road X Slope (%)	0.1	N/A	Clear Space to XWalk (in)	N/A
N/A	Any Obstructions?	N/A	N/A	Storm Grate/Utility Hazard?	N/A
	Obstruction Type			Storm Grate/Utility Type	
		N/A			N/A
			Yes	Surface Condition? (G/P)	Good
			No	Curb Slope (%)	8.1

Possible Solutions:

Remove & Replace Curb Ramp With Two New Directional Ramps or Equivalent.
