# Access Compliance Report

## Public Rights-of-Way

### (Curb Ramps)

| Intersection ID: 50633 | Main Street: BLUE_BLOSSOM_RD | Cross Street: CORAL_ROSE_RD | Location: SE |

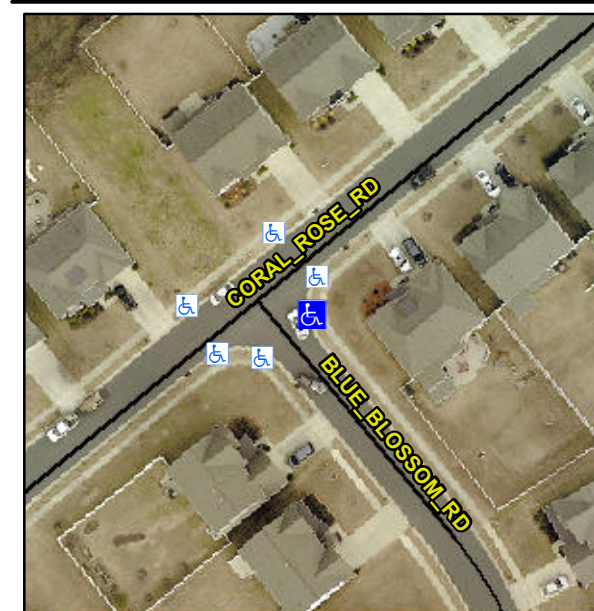
| ADA ID: 9B853D252DF1 | Ramp Type: Perp | Initial Pass/Fail: Fail | Overall Compliance: No |
| Severity Score: 1.25 | | | |

**Not Found, R304.5.3**

| Compliance | Description | Data | Compliance | Description | Data |
|---|---|---|---|---|---|
| Yes | Ramp Width (in) | 48.0 | No | Ramp XSlope (%) | 4.5 |

**Remove & Replace Entire Ramp.**
