Access Compliance Report

Public Rights-of-Way

(Curb Ramps)

Intersection ID: 5638	Main Street: BELLHAVEN_BV	Cross Street: KENTBERRY_DR	Location: S
ADA ID: 9B916C8794B3	Ramp Type: BlendTrans1	Initial Pass/Fail: Pass	Overall Compliance: No
		Severity Score: 2.5

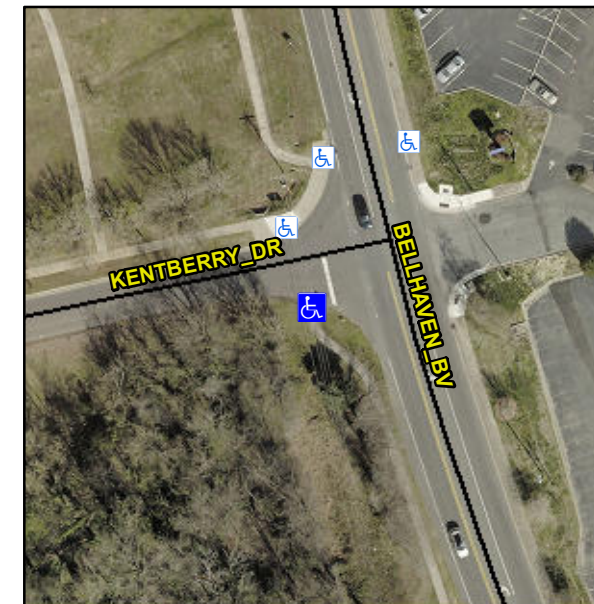
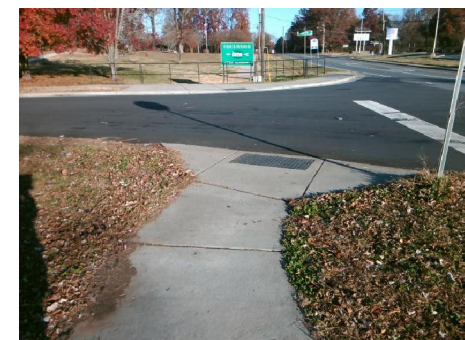
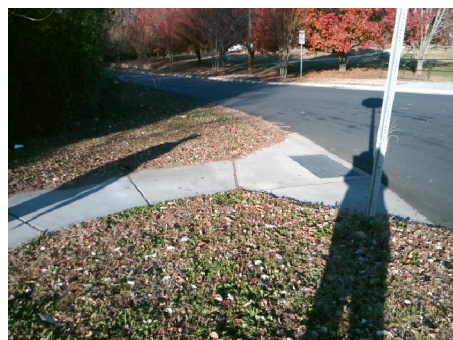
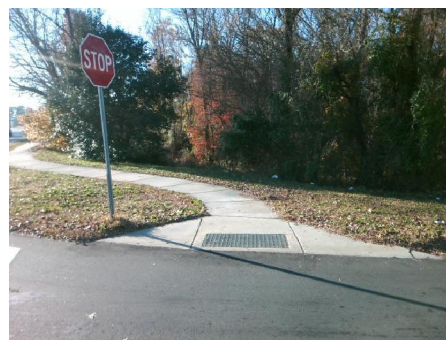
NO CURB

Compliance	Description	Data	Compliance	Description	Data
N/A	Ramp Length (in)	67.0	Yes	BlendTrans Slope (%)	0.3
Yes	Ramp Width (in)	59.5	Yes	BlendTrans XSlope (%)	0.9
N/A	Flare Type LT	Sloped	N/A	Flare Type RT	Sloped
N/A	Flare Slope LT (%)	N/A	N/A	Flare Slope RT (%)	N/A
N/A	Flare Traversable LT?	No	N/A	Flare Traversable RT?	No
No	Landing Length (in)	43.0	Yes	DWS Provided?	Yes
Yes	Landing Width (in)	59.0	Yes	DWS Contrast?	Yes
Yes	Landing Slope (%)	0.0	Yes	DWS Length (in)	24.0
Yes	Landing X Slope (%)	1.4	No	DWS Full Width?	No
N/A	Landing Curb? (Y/N)	No	No	DWS Offset (in)	6.5
N/A	Shared Landing?	No			
Yes	Gutter Ponding?	No	Yes	Gutter Slope (%)	0.8
Yes	Gutter Lip Ht (in)	0.0	Yes	Gutter X Slope (%)	1.1
N/A	Painted X Walk1?	No	N/A	Painted X Walk2?	N/A
	X Walk 1 Direction	To N		X Walk 2 Direction	N/A
	X Walk 1 Width (in)	N/A		X Walk 2 Width (in)	N/A
	X Walk 1 Slope (%)	3.1		X Walk 2 Slope (%)	N/A
	X Walk 1 X Slope (%)	1.3		X Walk 2 X Slope (%)	N/A

N/A	Ramp inside XWalk1?	N/A	N/A	Ramp inside XWalk2?	N/A
	Road Slope (%)	1.3		Clear Space?	Yes
	Road X Slope (%)	3.1	N/A	Clear Space to XWalk (in)	N/A
Yes	Any Obstructions?	No	Yes	Storm Grate/Utility Hazard?	No
	Obstruction Type			Storm Grate/Utility Type	
		N/A			N/A
			Yes	Surface Condition? (G/P)	Good
			N/A	Curb Slope (%)	N/A

Possible Solutions:

Remove & Replace Curb Ramp With Two New Directional Ramps or Equivalent.

R304.2.1, R305.1.4, R305.2
