## **Access Compliance Report Public Rights-of-Way** (Curb Ramps)

Intersection ID: 8967 Main Street: BRADFORD\_DR Cross Street: LYNN\_ST Location: NE **Overall Compliance: No** Severity Score: ADA ID: 9B9253D88568 Ramp Type: Perp Initial Pass/Fail: Fail 1.25

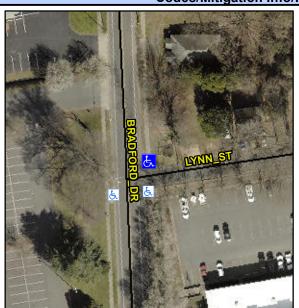
Field Measurements/Component Compliance						
Comp	liance Description	Data	Comp	liance	Description	Data
N/A	Ramp Length (in)	56.0	Yes	Ramp	Slope (%)	7.4
Yes	Ramp Width (in)	48.0	No	Ramp	XSlope (%)	3.3
N/A	Flare Type LT	N/A	N/A	Flare	Type RT	N/A
N/A	Flare Slope LT (%)	N/A	N/A	Flare	Slope RT (%)	N/A
N/A	Flare Traversable LT?	N/A	N/A	Flare	Traversable RT?	N/A
N/A	Landing Length (in)	N/A	N/A	DWS	Provided?	N/A
N/A	Landing Width (in)	N/A	N/A	DWS	Contrast?	N/A
N/A	Landing Slope (%)	N/A	N/A	DWS	Length (in)	N/A
N/A	Landing X Slope (%)	N/A	N/A	DWS	Full Width?	N/A
N/A	Landing Curb? (Y/N)	N/A	N/A	DWS	Offset (in)	N/A
N/A	Shared Landing?	N/A				
N/A	Gutter Ponding?	N/A	N/A	Gutte	r Slope (%)	N/A
N/A	Gutter Lip Ht (in)	N/A	N/A	Gutte	r X Slope (%)	N/A
N/A	Painted X Walk1?	No	N/A	Painte	ed X Walk2?	N/A
	X Walk 1 Direction	To S		X Wa	lk 2 Direction	N/A
N/A	X Walk 1 Width (in)	N/A	N/A	X Wa	lk 2 Width (in)	N/A
	X Walk 1 Slope (%)	1.3		X Wa	lk 2 Slope (%)	N/A

X Walk 1 X Slope (%)	9.6		X Wa	lk 2 X Slope (%)	N/A
N/A	Ramp inside XWalk1?	N/A	N/A	Ramp	inside XWalk2?	N/A
	Road Slope (%)	N/A	N/A	Clear	Space?	N/A
	Road X Slope (%)	N/A	N/A	Clear	Space to XWalk (in)	N/A
N/A	Any Obstructions?	N/A	N/A	Storm	Grate/Utility Hazard?	N/A
	Obstruction Type			Storm	Grate/Utility Type	
		N/A				N/A
			Yes	Surfa	ce Condition? (G/P)	Good

COCIDIO COIGLIOII			
Possible Solutions:	Comp	Compliance	
Remove & Replace Entire Ramp.	N/A	Ramp	
·	Yes	Ramp	
	N/A	Flare 1	
	N/A	Flare S	
	N/A	Flare T	
	N/A	Landin	
Surveyor Notes:	N/A	Landin	
N/A	N/A	Landin	
	N/A	Landin	
	N/A	Landin	
	N/A	Shared	
PROW/ADA:	N/A	Gutter	
Not Found, R304.5.3	N/A	Gutter	
	N/A	Painte	
		X Walk	
	N/A	X Walk	
		X Walk	
		X Walk	
	N/A	Ramp	
		Road S	
		Road 2
