Access Compliance Report

Public Rights-of-Way

(Curb Ramps)

| Intersection ID: 14360 | Main Street: BALDWIN_AV | Cross Street: MAIN_ST | Location: SE |

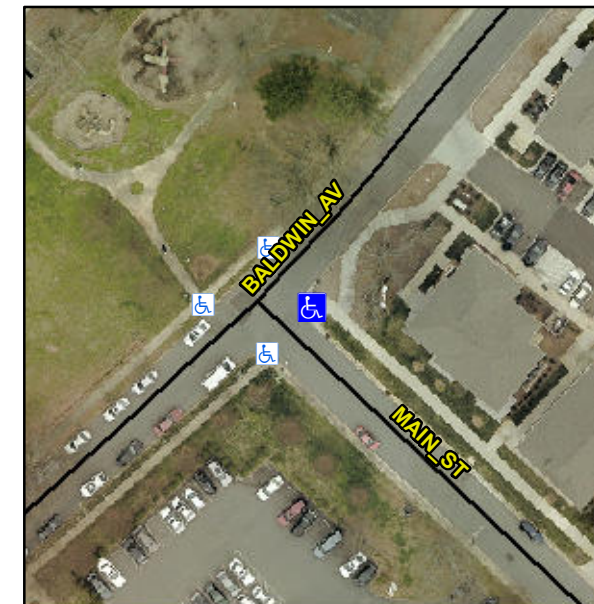
| ADA ID: 9B99E408CE8A | Ramp Type: Perp | Initial Pass/Fail: Fail | Overall Compliance: No |
| Severity Score: 12.5 | | | |

R304.2.2

| Compliance | Description | Data | Compliance | Description | Data |
|---|---|---|---|---|---|
| N/A | Ramp Length (in) | 71.0 | No | Ramp Slope (%) | 8.4 |

Possible Solutions:

Remove & Replace Entire Ramp.

Total Cost:

\$ 1850.00
