Access Compliance Report

Public Rights-of-Way

(Curb Ramps)

Intersection ID: 11289	Main Street: E_18TH_ST	Cross Street: PARKWOOD AV	Location: E
ADA ID: 9BA18709485F	Ramp Type: PerpDiag	Initial Pass/Fail: Fail	Overall Compliance: No
Severity Score: 21.25			
Codes/Mitigation Info/Possible Solution		Field Measurements/Component Compliance

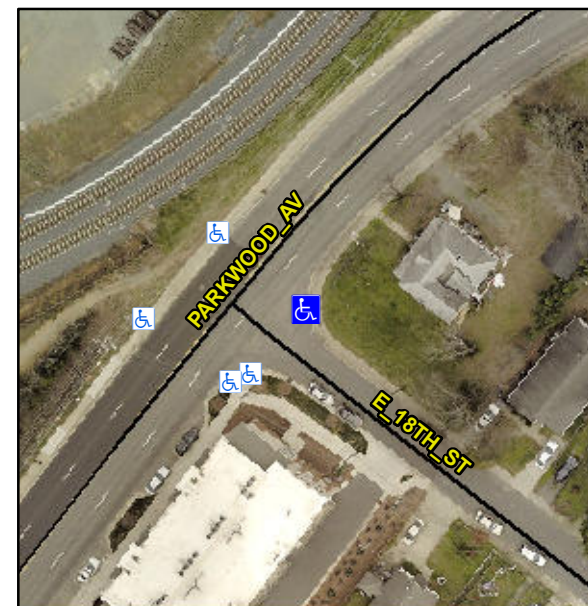
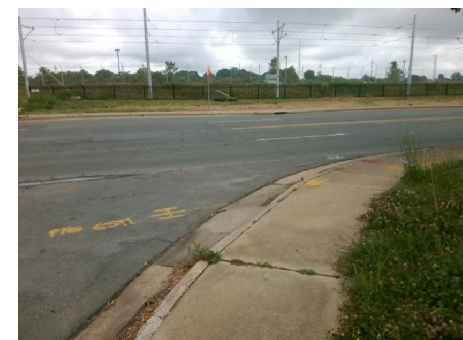
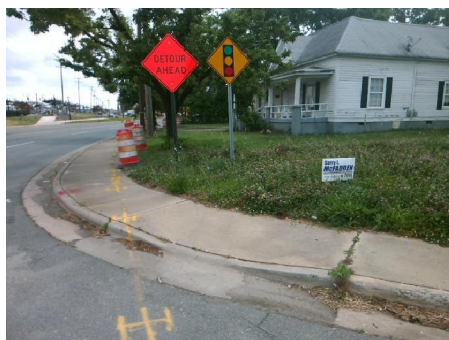
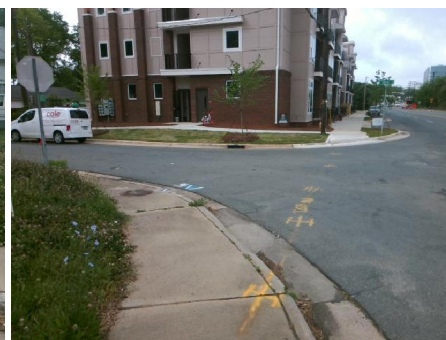
Not Found, R304.5.1, R304.2.2

Compliance	Description	Data	Compliance	Description	Data
N/A	Ramp Length (in)	58.0	No	Ramp Slope (%)	10.0
No	Ramp Width (in)	36.0	Yes	Ramp XSlope (%)	1.0
N/A	Flare Type LT	N/A	N/A	Flare Type RT	N/A
N/A	Flare Slope LT (%)	N/A	N/A	Flare Slope RT (%)	N/A
N/A	Flare Traversable LT?	N/A	N/A	Flare Traversable RT?	N/A
N/A	Landing Length (in)	N/A	N/A	DWS Provided?	N/A
N/A	Landing Width (in)	N/A	N/A	DWS Contrast?	N/A
N/A	Landing Slope (%)	N/A	N/A	DWS Length (in)	N/A
N/A	Landing X Slope (%)	N/A	N/A	DWS Full Width?	N/A
N/A	Landing Curb? (Y/N)	N/A	N/A	DWS Offset (in)	N/A
N/A	Shared Landing?	N/A			
N/A	Gutter Ponding?	N/A	N/A	Gutter Slope (%)	N/A
N/A	Gutter Lip Ht (in)	N/A	N/A	Gutter X Slope (%)	N/A
N/A	Painted X Walk1?	No	N/A	Painted X Walk2?	No
	X Walk 1 Direction	To NW		X Walk 2 Direction	To SW
N/A	X Walk 1 Width (in)	N/A	N/A	X Walk 2 Width (in)	N/A
	X Walk 1 Slope (%)	1.1		X Walk 2 Slope (%)	0.5
	X Walk 1 X Slope (%)	0.1		X Walk 2 X Slope (%)	0.6

N/A	Ramp inside XWalk1?	N/A	N/A	Ramp inside XWalk2?	N/A
	Road Slope (%)	0.9	N/A	Clear Space?	N/A
	Road X Slope (%)	1.6	N/A	Clear Space to XWalk (in)	N/A
N/A	Any Obstructions?	N/A	N/A	Storm Grate/Utility Hazard?	N/A
	Obstruction Type			Storm Grate/Utility Type	
		N/A			N/A
			Yes	Surface Condition? (G/P)	Good

Remove & Replace Curb Ramp With Two New Directional Ramps or Equivalent.

Total Cost: \$ **3200.00**
