Access Compliance Report Public Rights-of-Way (Curb Ramps)

Location: Intersection ID: 8680 Main Street: HILLSBORO AV **Cross Street: LAMBETH DR** SW Initial Pass/Fail: Fail **Overall Compliance: No** ADA ID: 9BA1A177204F Ramp Type: Perp Severity Score: 21.25

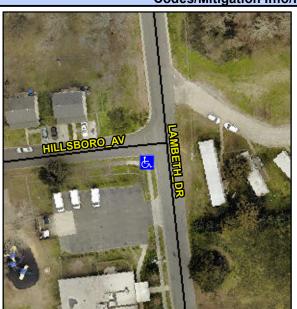
Ramp Slope (%)

58.0

| o/Possible Solution | Fiel | <u>a me</u> |
|---|---|---|
| Remove & Replace Entire Ramp. | N/A Ramp Length | (in) |
| Not Found, R304.5.1, R304.2.2 | N/A Gutter Lip Ht (| (in) |
